Access Compliance Report

Public Rights-of-Way

(Curb Ramps)

Intersection ID: 25823	Main Street: BANNINGTON_RD	Cross Street: PINEVILLE-MATTHEWS_RD	Location:	SE
ADA ID: B8C74CD7E63B	Ramp Type: BlendTrans1	Initial Pass/Fail: Pass	Overall Compliance: No	Severity Score: 15
Codes/Mitigation Info/Possible Solution		Field Measurements/Component Compliance

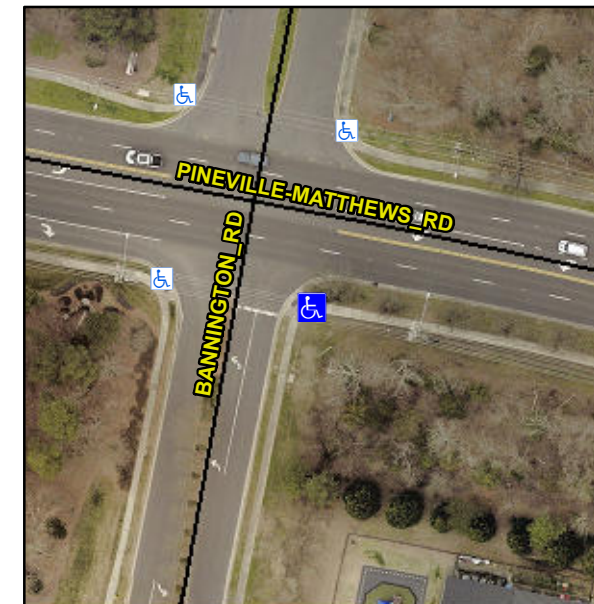
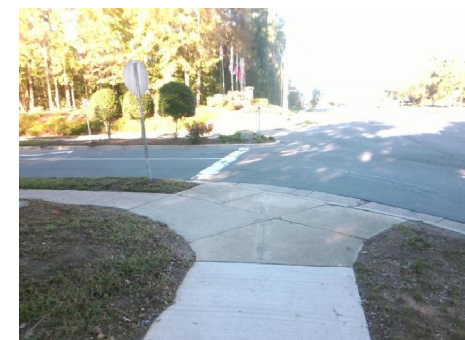
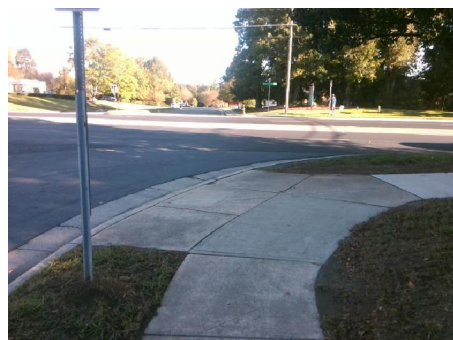
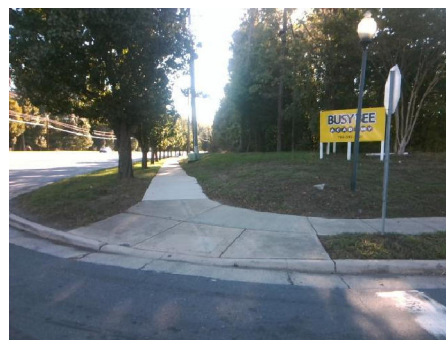
Compliance	Description	Data	Compliance	Description	Data
N/A	Ramp Length (in)	61.0	Yes	BlendTrans Slope (%)	4.0
Yes	Ramp Width (in)	55.0	Yes	BlendTrans XSlope (%)	1.7
N/A	Flare Type LT	Sloped	N/A	Flare Type RT	Sloped
N/A	Flare Slope LT (%)	3.8	N/A	Flare Slope RT (%)	3.8
N/A	Flare Traversable LT?	No	N/A	Flare Traversable RT?	No
Yes	Landing Length (in)	63.0	No	DWS Provided?	No
Yes	Landing Width (in)	58.0	N/A	DWS Contrast?	No
Yes	Landing Slope (%)	1.7	N/A	DWS Length (in)	N/A
Yes	Landing X Slope (%)	1.4	N/A	DWS Full Width?	No
N/A	Landing Curb? (Y/N)	No	N/A	DWS Offset (in)	N/A
N/A	Shared Landing?	No			
Yes	Gutter Ponding?	No	No	Gutter Slope (%)	11.1
Yes	Gutter Lip Ht (in)	0.0	Yes	Gutter X Slope (%)	0.5
N/A	Painted X Walk1?	No	N/A	Painted X Walk2?	No
	X Walk 1 Direction	To N		X Walk 2 Direction	To W
	X Walk 1 Width (in)	N/A		X Walk 2 Width (in)	N/A
	X Walk 1 Slope (%)	1.6		X Walk 2 Slope (%)	4.4
	X Walk 1 X Slope (%)	6.1		X Walk 2 X Slope (%)	2.6

N/A	Ramp inside XWalk1?	N/A	N/A	Ramp inside XWalk2?	N/A
	Road Slope (%)	0.2		Clear Space?	Yes
	Road X Slope (%)	6.0	N/A	Clear Space to XWalk (in)	N/A
Yes	Any Obstructions?	No	Yes	Storm Grate/Utility Hazard?	No
	Obstruction Type			Storm Grate/Utility Type	
		N/A			N/A
			Yes	Surface Condition? (G/P)	Good
			No	Curb Slope (%)	12.4

Possible Solutions:

Remove & Replace Curb Ramp With Two New Directional Ramps or Equivalent. Remove & Replace Gutter.
