Access Compliance Report

Public Rights-of-Way

(Curb Ramps)

Intersection ID: 27388	Main Street: CONLAN_CR	Cross Street: BRIXHAM_HILL_AV	Location: SW
ADA ID: B8C76AA0BE2D	Ramp Type: Perp	Initial Pass/Fail: Fail	Overall Compliance: No
		Severity Score: 22.5

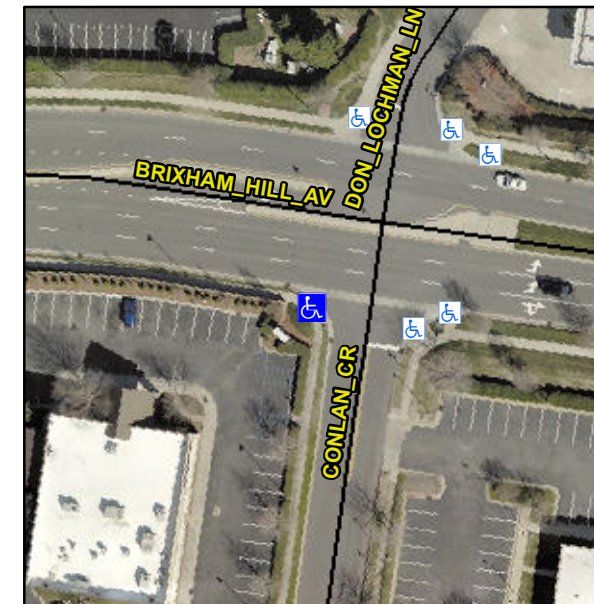
Not Found, R304.5.1, R304.2.2, R304.5.3

Compliance	Description	Data	Compliance	Description	Data
N/A	Ramp Length (in)	81.0	No	Ramp Slope (%)	8.5
No	Ramp Width (in)	47.5	No	Ramp XSlope (%)	3.0
N/A	Flare Type LT	N/A	N/A	Flare Type RT	N/A
N/A	Flare Slope LT (%)	N/A	N/A	Flare Slope RT (%)	N/A
N/A	Flare Traversable LT?	N/A	N/A	Flare Traversable RT?	N/A
N/A	Landing Length (in)	N/A	N/A	DWS Provided?	N/A
N/A	Landing Width (in)	N/A	N/A	DWS Contrast?	N/A
N/A	Landing Slope (%)	N/A	N/A	DWS Length (in)	N/A
N/A	Landing X Slope (%)	N/A	N/A	DWS Full Width?	N/A
N/A	Landing Curb? (Y/N)	N/A	N/A	DWS Offset (in)	N/A
N/A	Shared Landing?	N/A			
N/A	Gutter Ponding?	N/A	N/A	Gutter Slope (%)	N/A
N/A	Gutter Lip Ht (in)	N/A	N/A	Gutter X Slope (%)	N/A
N/A	Painted X Walk1?	No	N/A	Painted X Walk2?	N/A
	X Walk 1 Direction	To SE		X Walk 2 Direction	N/A
N/A	X Walk 1 Width (in)	N/A	N/A	X Walk 2 Width (in)	N/A
	X Walk 1 Slope (%)	2.1		X Walk 2 Slope (%)	N/A
	X Walk 1 X Slope (%)	3.0		X Walk 2 X Slope (%)	N/A

N/A	Ramp inside XWalk1?	N/A	N/A	Ramp inside XWalk2?	N/A
	Road Slope (%)	N/A	N/A	Clear Space?	N/A
	Road X Slope (%)	N/A	N/A	Clear Space to XWalk (in)	N/A
N/A	Any Obstructions?	N/A	N/A	Storm Grate/Utility Hazard?	N/A
	Obstruction Type			Storm Grate/Utility Type	
		N/A			N/A
			Yes	Surface Condition? (G/P)	Good

Remove & Replace Entire Ramp.
