Access Compliance Report

Public Rights-of-Way

(Curb Ramps)

Intersection ID: 31725	Main Street: MOSSYCUP_DR	Cross Street: GOLDENWILLOW_DR	Location: W
ADA ID: B8D79FD18E8A	Ramp Type: Perp	Initial Pass/Fail: Fail	Overall Compliance: No
Severity Score: 10			
Codes/Mitigation Info/Possible Solution		Field Measurements/Component Compliance

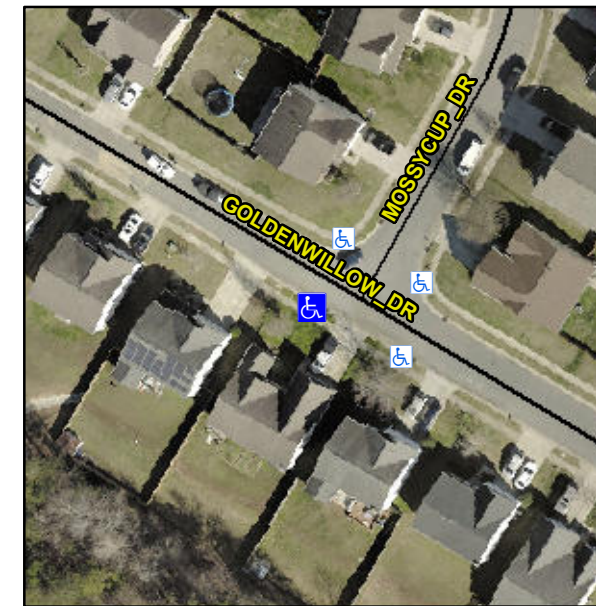
Not Found, R304.5.1

Compliance	Description	Data	Compliance	Description	Data
N/A	Ramp Length (in)	49.0	Yes	Ramp Slope (%)	5.9
No	Ramp Width (in)	47.0	Yes	Ramp XSlope (%)	2.3
N/A	Flare Type LT	N/A	N/A	Flare Type RT	N/A
N/A	Flare Slope LT (%)	N/A	N/A	Flare Slope RT (%)	N/A
N/A	Flare Traversable LT?	N/A	N/A	Flare Traversable RT?	N/A
N/A	Landing Length (in)	N/A	N/A	DWS Provided?	N/A
N/A	Landing Width (in)	N/A	N/A	DWS Contrast?	N/A
N/A	Landing Slope (%)	N/A	N/A	DWS Length (in)	N/A
N/A	Landing X Slope (%)	N/A	N/A	DWS Full Width?	N/A
N/A	Landing Curb? (Y/N)	N/A	N/A	DWS Offset (in)	N/A
N/A	Shared Landing?	N/A			
N/A	Gutter Ponding?	N/A	N/A	Gutter Slope (%)	N/A
N/A	Gutter Lip Ht (in)	N/A	N/A	Gutter X Slope (%)	N/A
N/A	Painted X Walk1?	No	N/A	Painted X Walk2?	N/A
	X Walk 1 Direction	To NE		X Walk 2 Direction	N/A
N/A	X Walk 1 Width (in)	N/A	N/A	X Walk 2 Width (in)	N/A
	X Walk 1 Slope (%)	1.3		X Walk 2 Slope (%)	N/A
	X Walk 1 X Slope (%)	3.1		X Walk 2 X Slope (%)	N/A

N/A	Ramp inside XWalk1?	N/A	N/A	Ramp inside XWalk2?	N/A
	Road Slope (%)	N/A	N/A	Clear Space?	N/A
	Road X Slope (%)	N/A	N/A	Clear Space to XWalk (in)	N/A
N/A	Any Obstructions?	N/A	N/A	Storm Grate/Utility Hazard?	N/A
	Obstruction Type			Storm Grate/Utility Type	
		N/A			N/A
			Yes	Surface Condition? (G/P)	Good

Possible Solutions:

Remove & Replace Entire Ramp.

Total Cost: \$ 1850.00
