Access Compliance Report Public Rights-of-Way (Curb Ramps)

Intersection ID: N/A	Main Street: PAMPLIN_CT	Cross Street: PAISLEY_ABBEY_LN	Location: SE
ADA ID: B8E3CC59D151	Ramp Type: Perp	Initial Pass/Fail: Fail	Overall Compliance: No Severity Score: 18.75

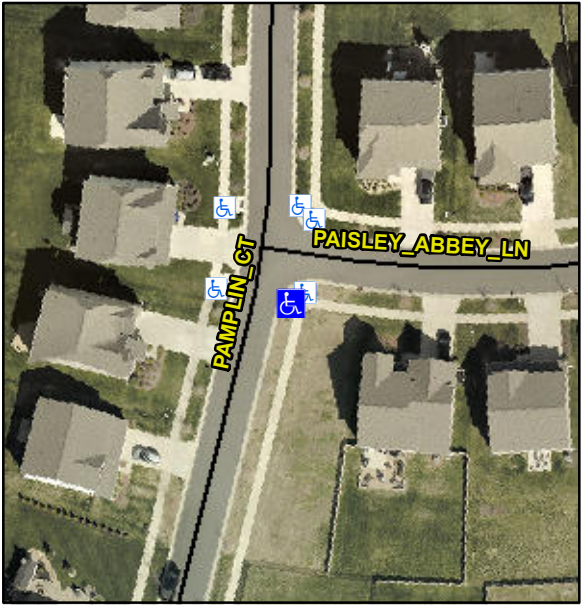
Compliance	Description	Data	Compliance	Description	Data
N/A	Ramp Length (in)	96.0	Yes	Ramp Slope (%)	7.5
No	Ramp Width (in)	35.0	Yes	Ramp XSlope (%)	2.1
N/A	Flare Type LT	N/A	N/A	Flare Type RT	N/A
N/A	Flare Slope LT (%)	N/A	N/A	Flare Slope RT (%)	N/A
N/A	Flare Traversable LT?	N/A	N/A	Flare Traversable RT?	N/A
N/A	Landing Length (in)	N/A	N/A	DWS Provided?	N/A
N/A	Landing Width (in)	N/A	N/A	DWS Contrast?	N/A
N/A	Landing Slope (%)	N/A	N/A	DWS Length (in)	N/A
N/A	Landing X Slope (%)	N/A	N/A	DWS Full Width?	N/A
N/A	Landing Curb? (Y/N)	N/A	N/A	DWS Offset (in)	N/A
N/A	Shared Landing?	N/A			
N/A	Gutter Ponding?	N/A	N/A	Gutter Slope (%)	N/A
N/A	Gutter Lip Ht (in)	N/A	N/A	Gutter X Slope (%)	N/A
N/A	Painted X Walk1?	No	N/A	Painted X Walk2?	N/A
	X Walk 1 Direction	To NW		X Walk 2 Direction	N/A
N/A	X Walk 1 Width (in)	N/A	N/A	X Walk 2 Width (in)	N/A
	X Walk 1 Slope (%)	4.9		X Walk 2 Slope (%)	N/A
	X Walk 1 X Slope (%)	2.8		X Walk 2 X Slope (%)	N/A

N/A	Ramp inside XWalk1?	N/A	N/A	Ramp inside XWalk2?	N/A
	Road Slope (%)	N/A	N/A	Clear Space?	N/A
	Road X Slope (%)	N/A	N/A	Clear Space to XWalk (in)	N/A
N/A	Any Obstructions?	N/A	N/A	Storm Grate/Utility Hazard?	N/A
	Obstruction Type			Storm Grate/Utility Type	
			N/A		N/A
			Yes	Surface Condition? (G/P)	Good

Possible Solutions:
Remove & Replace Entire Ramp.
