# Access Compliance Report

## Public Rights-of-Way

| Intersection ID: 43480 | Main Street: LIONESS_ST | Cross Street: ERWIN_RD | Location: NE |
| ADA ID: B8E3F0FDE25A | Ramp Type: PerpDiag | Initial Pass/Fail: Pass | Overall Compliance: No |

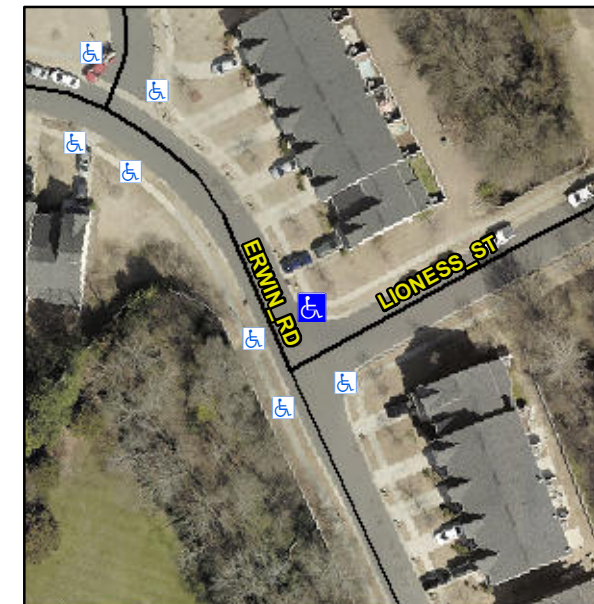
**Not Found, R304.5.3**

| Compliance | Description | Data | Compliance | Description | Data |
|---|---|---|---|---|---|
| Yes | Ramp Width (in) | 48.0 | No | Ramp XSlope (%) | 4.5 |
| No | Landing X Slope (%) | 3.8 | Yes | DWS Full Width? | Yes |
| Yes | Gutter Lip Ht (in) | 0.0 | No | Gutter X Slope (%) | 2.6 |

**Remove & Replace Curb Ramp With Two New Directional Ramps or Equivalent. Remove & Replace Gutter.**
