# Access Compliance Report

## Public Rights-of-Way

### (Curb Ramps)

| Intersection ID: 10022967 | Main Street: CEDAR_WALK_LN | Cross Street: N/A | Location: S |

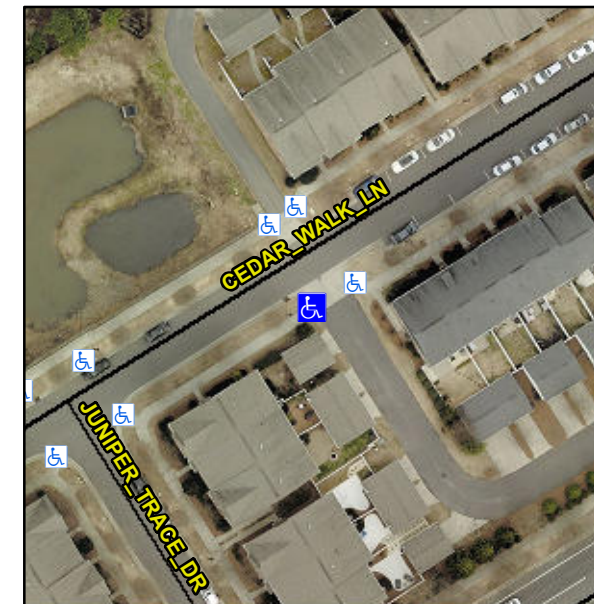
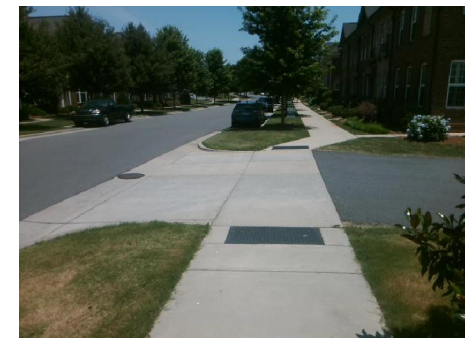
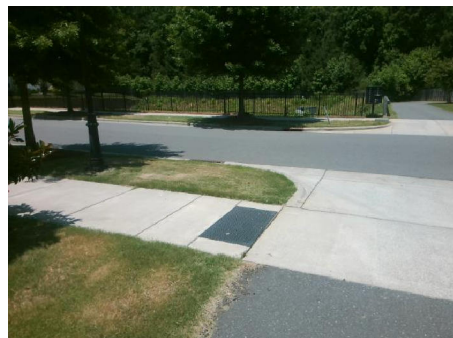
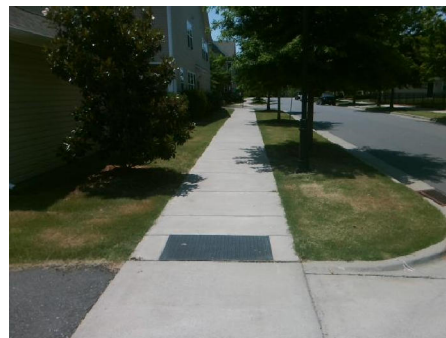
| ADA ID: B8F80DD4F268 | Ramp Type: BlendTrans1 | Initial Pass/Fail: Pass | Overall Compliance: No |

**R304.2.1, R304.5.3**

| Compliance | Description | Data | Compliance | Description | Data |
|---|---|---|---|---|---|
| No | Landing Length (in) | 26.5 | Yes | DWS Provided? | Yes |
| No | Landing X Slope (%) | 3.0 | Yes | DWS Full Width? | Yes |

**Remove & Replace Landing.**

**\$ 500.00**
