# Access Compliance Report

## Public Rights-of-Way

### (Curb Ramps)

| Intersection ID: 43500 | Main Street: MCALLISTER_PARK_DR | Cross Street: WILFORD_CT | Location: E |

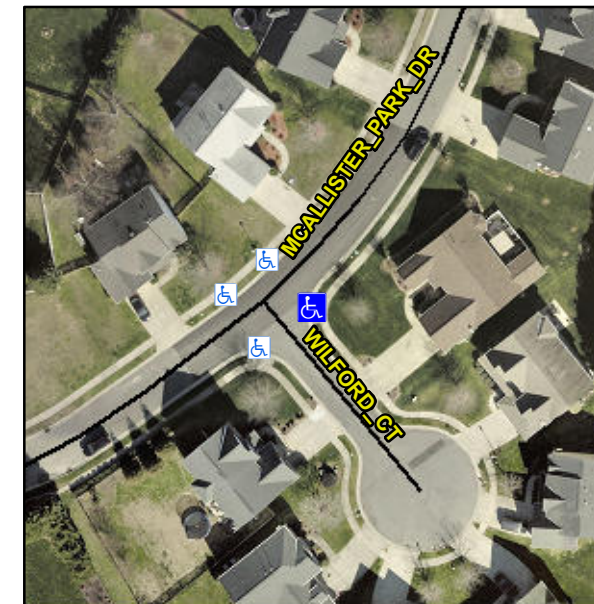
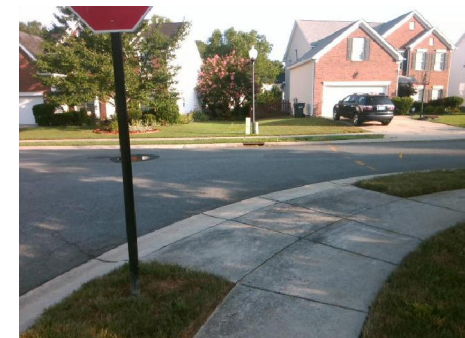
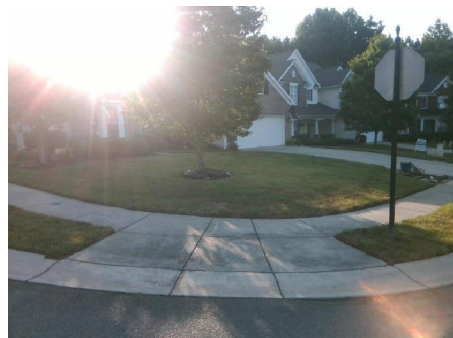
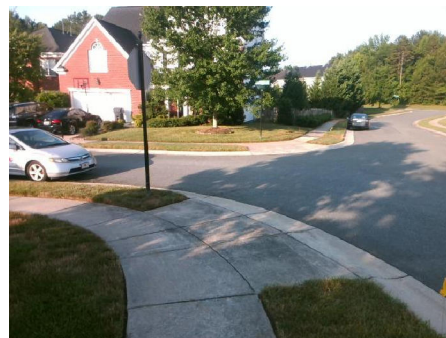
| ADA ID: B8FFA5F50F67 | Ramp Type: BlendTrans1 | Initial Pass/Fail: Fail | Overall Compliance: No |
| Severity Score: 21.25 | | | |

**Not Found, R304.5.1, R304.5.3**

| Compliance | Description | Data | Compliance | Description | Data |
|---|---|---|---|---|---|
| No | Ramp Width (in) | 37.0 | No | BlendTrans XSlope (%) | 6.1 |

**Remove & Replace Curb Ramp With Two New Directional Ramps or Equivalent.**
