Access Compliance Report Public Rights-of-Way (Curb Ramps)

Intersection ID: 11891 Main Street: N POPLAR ST Cross Street: W_6TH_ST Location:

ADA ID: B903FAB5C9FD Ramp Type: PerpDiag Initial Pass/Fail: Pass **Overall Compliance: No** Severity Score: 22.75

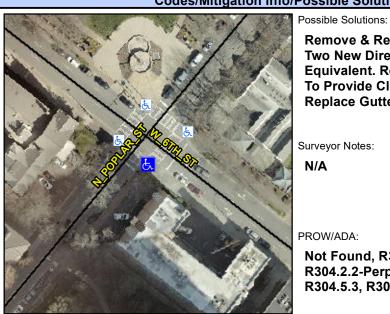
Not Found, R304.2.2, R304.2.1, R304.2.2-Perp, R304.3.2-Para, R304.5.3, R305

Compliance Description Data		Data	Compliance Description		Data
N/A	Ramp Length (in)	72.0	No	Ramp Slope (%)	9.3
Yes	Ramp Width (in)	60.0	Yes	Ramp XSlope (%)	2.8
N/A	Flare Type LT	Sloped	N/A	Flare Type RT	N/A
N/A	Flare Slope LT (%)	1.6	N/A	Flare Slope RT (%)	9.9
N/A	Flare Traversable LT?	Yes	N/A	Flare Traversable RT?	No
No	Landing Length (in)	N/A	No	DWS Provided?	No
No	Landing Width (in)	N/A	N/A	DWS Contrast?	No
No	Landing Slope (%)	N/A	N/A	DWS Length (in)	N/A
No	Landing X Slope (%)	N/A	N/A	DWS Full Width?	No
N/A	Landing Curb? (Y/N)	No	N/A	DWS Offset (in)	N/A
N/A	Shared Landing?	No			
Yes	Gutter Ponding?	No	Yes	Gutter Slope (%)	2.0
Yes	Gutter Lip Ht (in)	0.0	No	Gutter X Slope (%)	4.9
N/A	Painted X Walk1?	Yes	N/A	Painted X Walk2?	Yes
	X Walk 1 Direction	To NW		X Walk 2 Direction	To NE
N/A	X Walk 1 Width (in)	136.0	N/A	X Walk 2 Width (in)	137.0
	X Walk 1 Slope (%)	1.4		X Walk 2 Slope (%)	1.4
	X Walk 1 X Slope (%)	1.1		X Walk 2 X Slope (%)	1.0

Yes	Ramp inside XWalk1?	Yes	Yes	Ramp inside XWalk2?	Yes
	Road Slope (%)	3.9	N/A	Clear Space?	Yes
	Road X Slope (%)	0.6	No	Clear Space to XWalk (in)	30.0
Yes	Any Obstructions?	No	Yes	Storm Grate/Utility Hazard?	No
	Obstruction Type			Storm Grate/Utility Type	
		N/A			N/A
			Yes	Surface Condition? (G/P)	Good

Remove & Replace Curb Ramp With Two New Directional Ramps or Equivalent. Restripe Crosswalk(s) To Provide Clear space. Remove & Replace Gutter.

Total Cost: 4450.00
