Access Compliance Report

Public Rights-of-Way

Intersection ID: 20439	Main Street: FAIRVIEW_RD	Cross Street: SHARON_RD	Location: NE
ADA ID: B9073A99B38B	Ramp Type: Perp	Initial Pass/Fail: Fail	Overall Compliance: No
Severity Score: 8.75			
Codes/Mitigation Info/Possible Solution		Field Measurements/Component Compliance

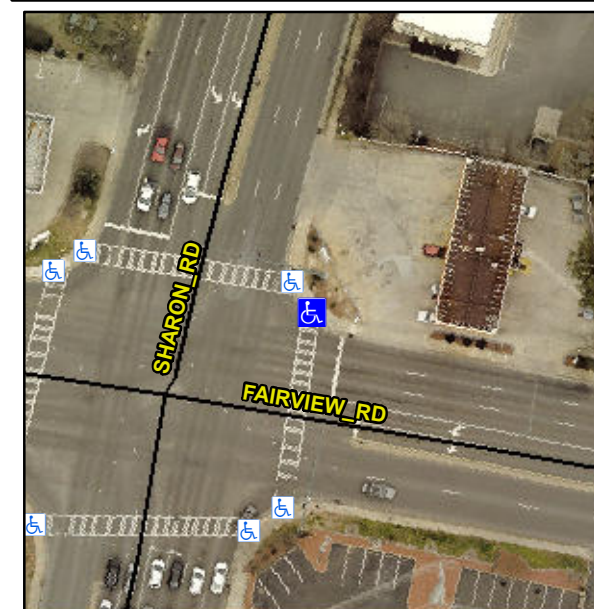
Not Found, R304.5.1

Compliance	Description	Data	Compliance	Description	Data
N/A	Ramp Length (in)	85.0	Yes	Ramp Slope (%)	6.5
No	Ramp Width (in)	39.0	Yes	Ramp XSlope (%)	0.7
N/A	Flare Type LT	N/A	N/A	Flare Type RT	N/A
N/A	Flare Slope LT (%)	N/A	N/A	Flare Slope RT (%)	N/A
N/A	Flare Traversable LT?	N/A	N/A	Flare Traversable RT?	N/A
N/A	Landing Length (in)	N/A	N/A	DWS Provided?	N/A
N/A	Landing Width (in)	N/A	N/A	DWS Contrast?	N/A
N/A	Landing Slope (%)	N/A	N/A	DWS Length (in)	N/A
N/A	Landing X Slope (%)	N/A	N/A	DWS Full Width?	N/A
N/A	Landing Curb? (Y/N)	N/A	N/A	DWS Offset (in)	N/A
N/A	Shared Landing?	N/A			
N/A	Gutter Ponding?	N/A	N/A	Gutter Slope (%)	N/A
N/A	Gutter Lip Ht (in)	N/A	N/A	Gutter X Slope (%)	N/A
N/A	Painted X Walk1?	Yes	N/A	Painted X Walk2?	N/A
	X Walk 1 Direction	To SW		X Walk 2 Direction	N/A
N/A	X Walk 1 Width (in)	96.0	N/A	X Walk 2 Width (in)	N/A
	X Walk 1 Slope (%)	1.8		X Walk 2 Slope (%)	N/A
	X Walk 1 X Slope (%)	0.5		X Walk 2 X Slope (%)	N/A

N/A	Ramp inside XWalk1?	Yes	N/A	Ramp inside XWalk2?	N/A
	Road Slope (%)	N/A	N/A	Clear Space?	N/A
	Road X Slope (%)	N/A	N/A	Clear Space to XWalk (in)	N/A
N/A	Any Obstructions?	N/A	N/A	Storm Grate/Utility Hazard?	N/A
	Obstruction Type			Storm Grate/Utility Type	
		N/A			N/A
		Yes		Surface Condition? (G/P)	Good

Possible Solutions:

Remove & Replace Entire Ramp.
