# Access Compliance Report

## Public Rights-of-Way

### (Curb Ramps)

Intersection ID: 14851	Main Street: E_WORTHINGTON_AV	Cross Street: PARK_RD	Location:	W
ADA ID: B9077C72F51C	Ramp Type: Perp	Initial Pass/Fail: Fail	Overall Compliance: No	Severity Score: 1.25
Codes/Mitigation Info/Possible Solution		Field Measurements/Component Compliance

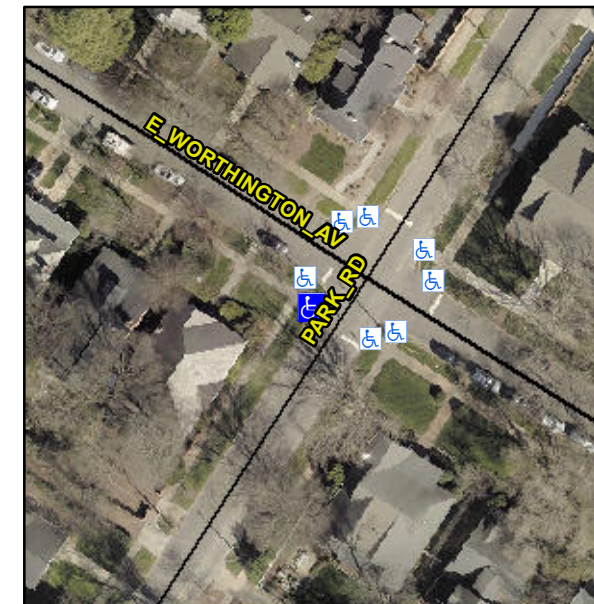
**Not Found, R304.5.3**

Compliance	Description	Data	Compliance	Description	Data
N/A	Ramp Length (in)	31.5	Yes	Ramp Slope (%)	5.4
Yes	Ramp Width (in)	48.0	No	Ramp XSlope (%)	4.2
N/A	Flare Type LT	N/A	N/A	Flare Type RT	N/A
N/A	Flare Slope LT (%)	N/A	N/A	Flare Slope RT (%)	N/A
N/A	Flare Traversable LT?	N/A	N/A	Flare Traversable RT?	N/A
N/A	Landing Length (in)	N/A	N/A	DWS Provided?	N/A
N/A	Landing Width (in)	N/A	N/A	DWS Contrast?	N/A
N/A	Landing Slope (%)	N/A	N/A	DWS Length (in)	N/A
N/A	Landing X Slope (%)	N/A	N/A	DWS Full Width?	N/A
N/A	Landing Curb? (Y/N)	N/A	N/A	DWS Offset (in)	N/A
N/A	Shared Landing?	N/A			
N/A	Gutter Ponding?	N/A	N/A	Gutter Slope (%)	N/A
N/A	Gutter Lip Ht (in)	N/A	N/A	Gutter X Slope (%)	N/A
N/A	Painted X Walk1?	No	N/A	Painted X Walk2?	N/A
	X Walk 1 Direction	To SE		X Walk 2 Direction	N/A
N/A	X Walk 1 Width (in)	N/A	N/A	X Walk 2 Width (in)	N/A
	X Walk 1 Slope (%)	2.3		X Walk 2 Slope (%)	N/A
	X Walk 1 X Slope (%)	0.2		X Walk 2 X Slope (%)	N/A

**Remove & Replace Entire Ramp.**

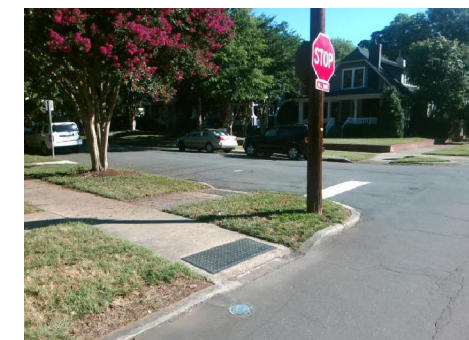
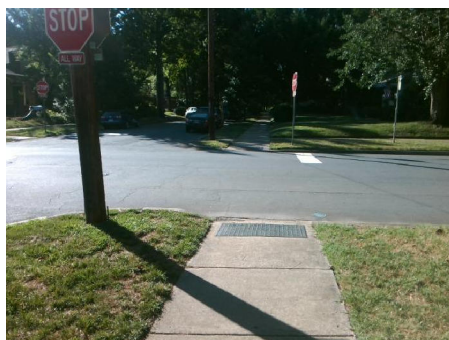
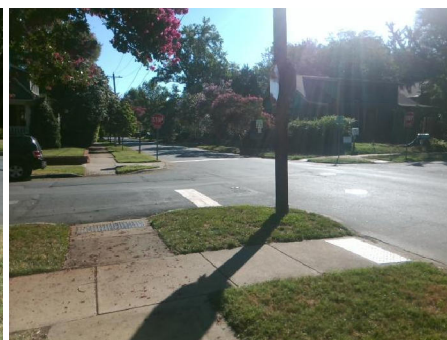
N/A	Ramp inside XWalk1?	N/A	N/A	Ramp inside XWalk2?	N/A
	Road Slope (%)	N/A	N/A	Clear Space?	N/A
	Road X Slope (%)	N/A	N/A	Clear Space to XWalk (in)	N/A
N/A	Any Obstructions?	N/A	N/A	Storm Grate/Utility Hazard?	N/A
	Obstruction Type			Storm Grate/Utility Type	
		N/A			N/A
			Yes	Surface Condition? (G/P)	Good
