Access Compliance Report

Public Rights-of-Way

(Curb Ramps)

Intersection ID: 29334	Main Street: ABERDEEN_GLEN_PL	Cross Street: BELLE_BRAGG_WY	Location:	N/A
ADA ID: B907EA58E768	Ramp Type: Perp	Initial Pass/Fail: Fail	Overall Compliance: No	Severity Score: 8.75

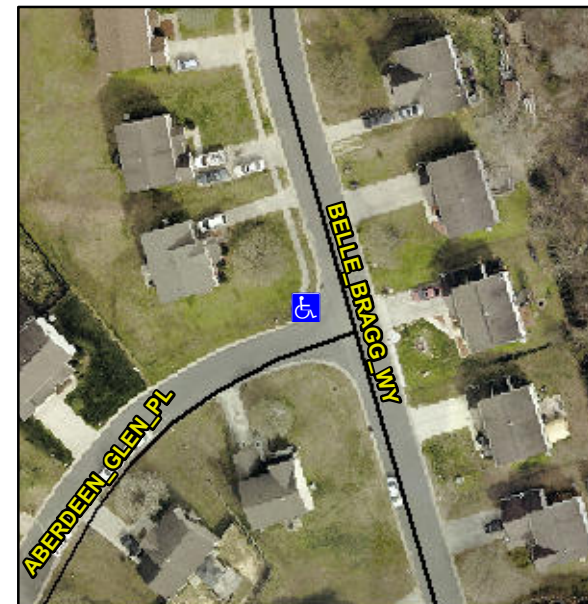
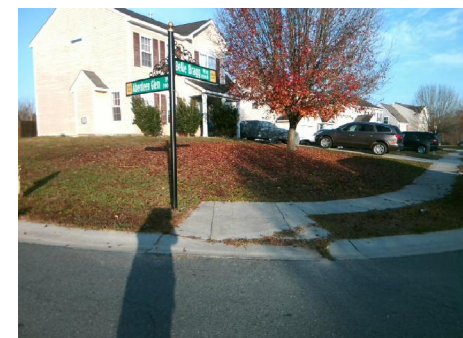
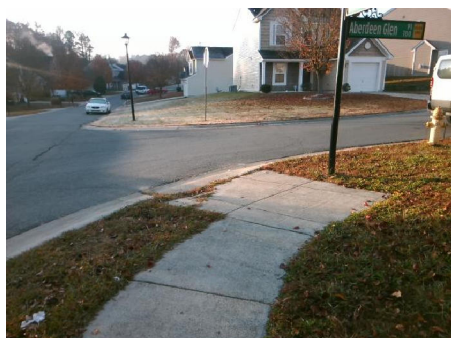
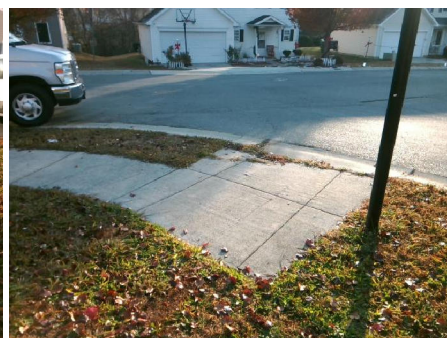
Not Found, R304.5.1

Compliance	Description	Data	Compliance	Description	Data
N/A	Ramp Length (in)	49.0	Yes	Ramp Slope (%)	5.2
No	Ramp Width (in)	47.5	Yes	Ramp XSlope (%)	0.7
N/A	Flare Type LT	N/A	N/A	Flare Type RT	N/A
N/A	Flare Slope LT (%)	N/A	N/A	Flare Slope RT (%)	N/A
N/A	Flare Traversable LT?	N/A	N/A	Flare Traversable RT?	N/A
N/A	Landing Length (in)	N/A	N/A	DWS Provided?	N/A
N/A	Landing Width (in)	N/A	N/A	DWS Contrast?	N/A
N/A	Landing Slope (%)	N/A	N/A	DWS Length (in)	N/A
N/A	Landing X Slope (%)	N/A	N/A	DWS Full Width?	N/A
N/A	Landing Curb? (Y/N)	N/A	N/A	DWS Offset (in)	N/A
N/A	Shared Landing?	N/A			
N/A	Gutter Ponding?	N/A	N/A	Gutter Slope (%)	N/A
N/A	Gutter Lip Ht (in)	N/A	N/A	Gutter X Slope (%)	N/A
N/A	Painted X Walk1?	No	N/A	Painted X Walk2?	N/A
	X Walk 1 Direction	To S		X Walk 2 Direction	N/A
N/A	X Walk 1 Width (in)	N/A	N/A	X Walk 2 Width (in)	N/A
	X Walk 1 Slope (%)	3.8		X Walk 2 Slope (%)	N/A
	X Walk 1 X Slope (%)	3.1		X Walk 2 X Slope (%)	N/A

N/A	Ramp inside XWalk1?	N/A	N/A	Ramp inside XWalk2?	N/A
	Road Slope (%)	3.1	N/A	Clear Space?	N/A
	Road X Slope (%)	3.8	N/A	Clear Space to XWalk (in)	N/A
N/A	Any Obstructions?	N/A	N/A	Storm Grate/Utility Hazard?	N/A
	Obstruction Type			Storm Grate/Utility Type	
		N/A			N/A
			Yes	Surface Condition? (G/P)	Good

Remove & Replace Entire Ramp.

Total Cost: \$ **1850.00**
