# Access Compliance Report

## Public Rights-of-Way

### (Curb Ramps)

| Intersection ID: 3322 | Main Street: CANTERBROOK_DR | Cross Street: TURTLE_CROSS_LN | Location: NW |

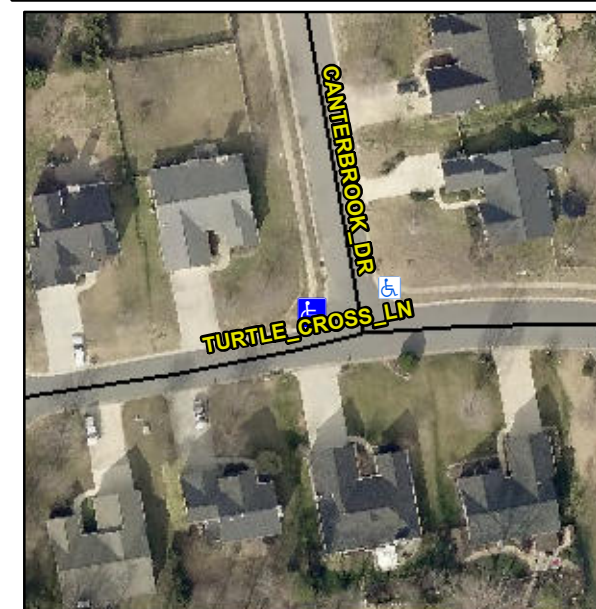
| ADA ID: B90B55E02562 | Ramp Type: Perp | Initial Pass/Fail: Fail | Overall Compliance: No |
| Severity Score: 18.75 | | | |

**R304.5.1, R304.5.3**

| Compliance | Description | Data | Compliance | Description | Data |
|---|---|---|---|---|---|
| No | Ramp Width (in) | 34.0 | No | Ramp XSlope (%) | 2.9 |

**Remove & Replace Entire Ramp.**

Total Cost: \$ 1850.00
