Access Compliance Report

Public Rights-of-Way

(Curb Ramps)

Intersection ID: N/A	Main Street: SPEER_BV	Cross Street: ZILKER_PARK_DR	Location: W
ADA ID: B90FB189F183	Ramp Type: Directional1	Initial Pass/Fail: Fail	Overall Compliance: No
Severity Score: 12.5			
Codes/Mitigation Info/Possible Solution		Field Measurements/Component Compliance

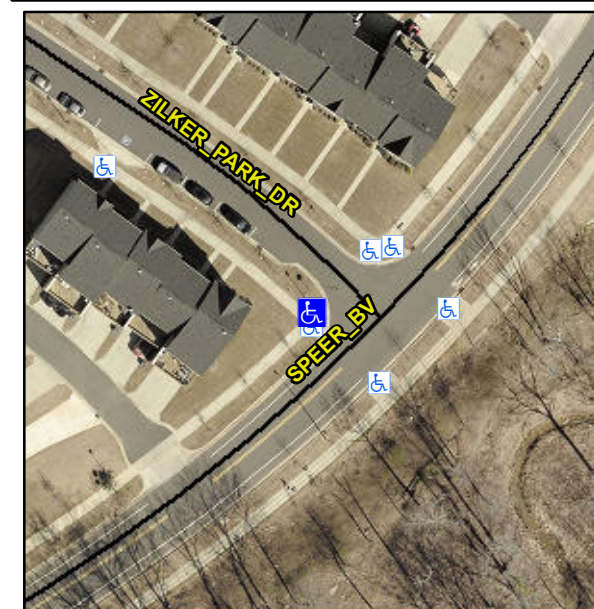
Compliance	Description	Data	Compliance	Description	Data
N/A	Ramp Length (in)	58.0	N/A	Grade Break?	N/A
Yes	Ramp Width (in)	76.0	N/A	Grade Break Slope (%)	0.0
No	Ramp Slope (%)	8.8	N/A	Grade Break XSlope (%)	0.0
Yes	Ramp XSlope (%)	0.7			
N/A	Flare Type LT	N/A	N/A	Flare Type RT	N/A
N/A	Flare Slope LT (%)	N/A	N/A	Flare Slope RT (%)	0.0
N/A	Flare Traversable LT?	N/A	N/A	Flare Traversable RT?	N/A
N/A	Landing Length (in)	0.0	N/A	DWS Provided?	N/A
N/A	Landing Width (in)	0.0	N/A	DWS Contrast?	N/A
N/A	Landing Slope (%)	0.0	N/A	DWS Length (in)	N/A
N/A	Landing X Slope (%)	0.0	N/A	DWS Full Width?	N/A
N/A	Landing Curb? (Y/N)	N/A	N/A	DWS Offset LT (in)	N/A
N/A	Shared Landing?	N/A	N/A	DWS Offset RT (in)	N/A
N/A	Gutter Ponding?	0.0	N/A	Gutter Slope (%)	N/A
N/A	Gutter Lip Ht (in)	0.0	N/A	Gutter X Slope (%)	N/A
N/A	Painted X Walk1?	No		Road Slope (%)	0.2
	X Walk 1 Direction	To NE		Road X Slope (%)	3.1
	X Walk 1 Width (in)	N/A		Clear Space?	N/A

Possible Solutions:

Remove & Replace Entire Ramp.

R304.2.2

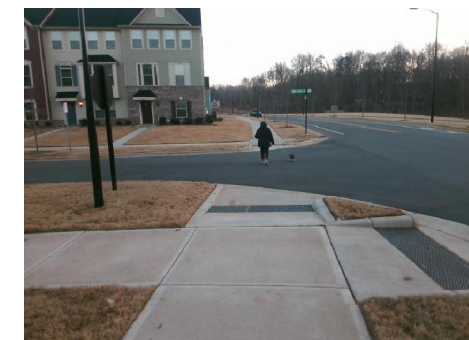
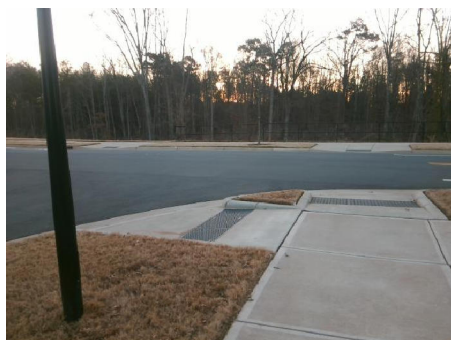
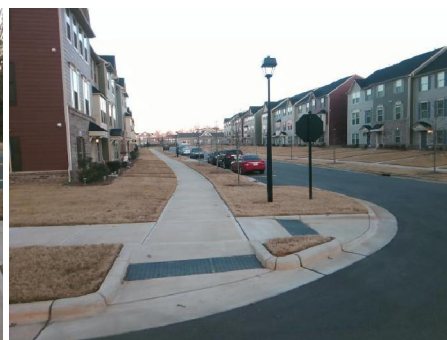
X Walk 1 Slope (%)	0.2	N/A	Clear Space to XWalk (in)	N/A
	X Walk 1 X Slope (%)	3.1	N/A	Storm Grate/Utility Hazard?	N/A
N/A	Ramp inside XWalk1?	N/A		Storm Grate/Utility Type	
N/A	Any Obstructions?	N/A			N/A
	Obstruction Type		Yes	Surface Condition? (G/P)	Good
			N/A	Curb Slope (%)	16.5
