Access Compliance Report

Public Rights-of-Way

(Curb Ramps)

Intersection ID: 42722	Main Street: WAKEROBIN_LN	Cross Street: BACK_CREEK_CHURCH_RD	Location: N
ADA ID: B913C4C0DBAD	Ramp Type: Perp	Initial Pass/Fail: Fail	Overall Compliance: No
Severity Score: 8.75			
Codes/Mitigation Info/Possible Solution		Field Measurements/Component Compliance

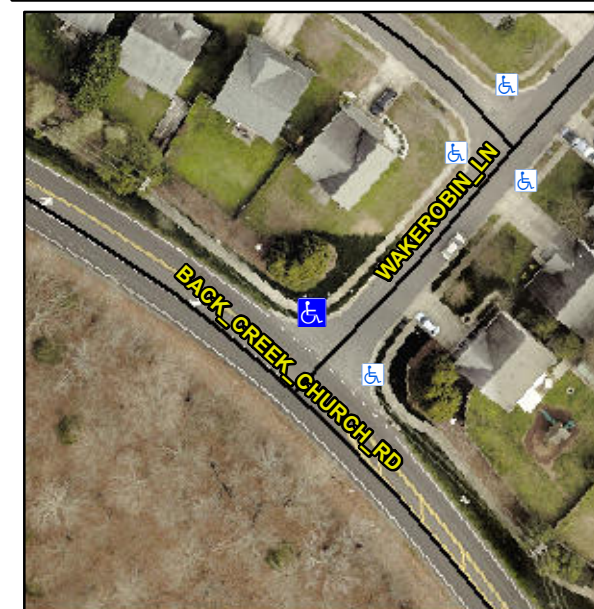
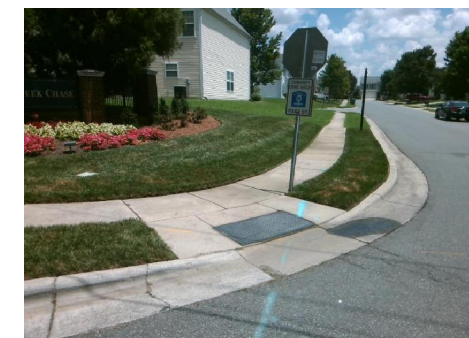
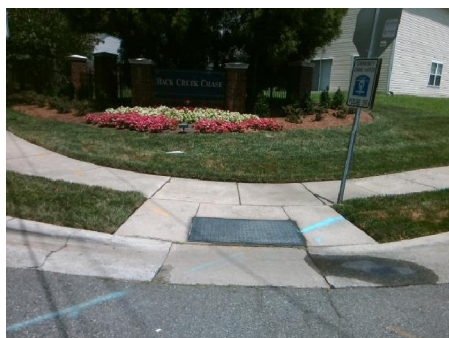
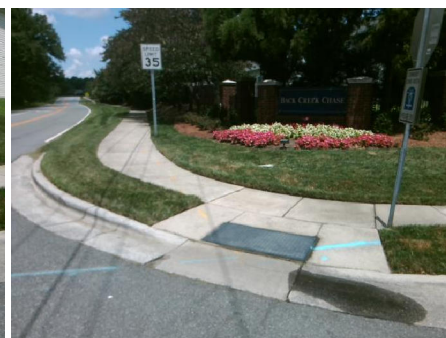
Compliance	Description	Data	Compliance	Description	Data
N/A	Ramp Length (in)	49.0	Yes	Ramp Slope (%)	5.1
No	Ramp Width (in)	44.0	Yes	Ramp XSlope (%)	0.7
N/A	Flare Type LT	N/A	N/A	Flare Type RT	N/A
N/A	Flare Slope LT (%)	N/A	N/A	Flare Slope RT (%)	N/A
N/A	Flare Traversable LT?	N/A	N/A	Flare Traversable RT?	N/A
N/A	Landing Length (in)	N/A	N/A	DWS Provided?	N/A
N/A	Landing Width (in)	N/A	N/A	DWS Contrast?	N/A
N/A	Landing Slope (%)	N/A	N/A	DWS Length (in)	N/A
N/A	Landing X Slope (%)	N/A	N/A	DWS Full Width?	N/A
N/A	Landing Curb? (Y/N)	N/A	N/A	DWS Offset (in)	N/A
N/A	Shared Landing?	N/A			
N/A	Gutter Ponding?	N/A	N/A	Gutter Slope (%)	N/A
N/A	Gutter Lip Ht (in)	N/A	N/A	Gutter X Slope (%)	N/A
N/A	Painted X Walk1?	No	N/A	Painted X Walk2?	N/A
	X Walk 1 Direction	To SE		X Walk 2 Direction	N/A
N/A	X Walk 1 Width (in)	N/A	N/A	X Walk 2 Width (in)	N/A
	X Walk 1 Slope (%)	0.5		X Walk 2 Slope (%)	N/A
	X Walk 1 X Slope (%)	1.6		X Walk 2 X Slope (%)	N/A

N/A	Ramp inside XWalk1?	N/A	N/A	Ramp inside XWalk2?	N/A
	Road Slope (%)	N/A	N/A	Clear Space?	N/A
	Road X Slope (%)	N/A	N/A	Clear Space to XWalk (in)	N/A
N/A	Any Obstructions?	N/A	N/A	Storm Grate/Utility Hazard?	N/A
	Obstruction Type			Storm Grate/Utility Type	
		N/A			N/A
			Yes	Surface Condition? (G/P)	Good

Possible Solutions:

Remove & Replace Entire Ramp.

Total Cost: \$ 1850.00
