# Access Compliance Report

## Public Rights-of-Way

### (Curb Ramps)

| Intersection ID: 53920 | Main Street: STEVIE_OAKS_LN | Cross Street: BRITTONDALE_LN | Location: SE |

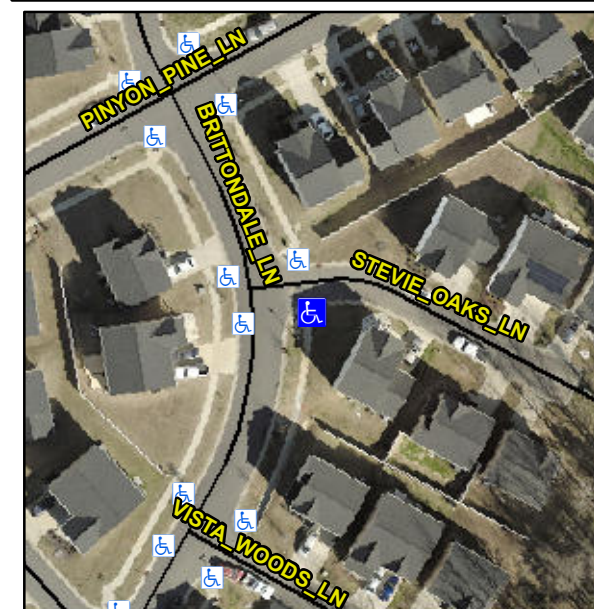
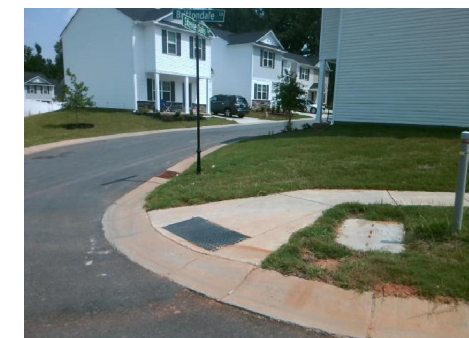
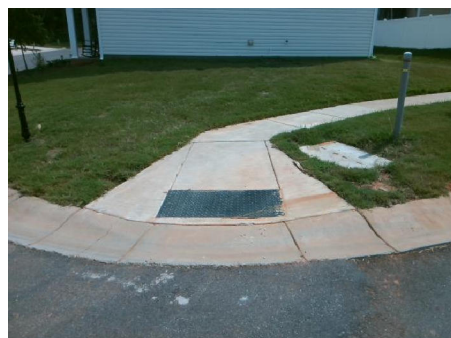
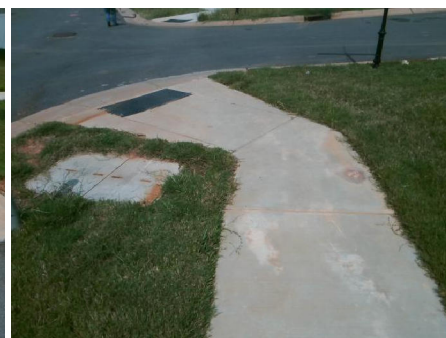
| ADA ID: B914B3EFFF8F | Ramp Type: PerpDiag | Initial Pass/Fail: Fail | Overall Compliance: No |

**Not Found, R304.5.1, R304.5.3**

| Compliance | Description | Data | Compliance | Description | Data |
|---|---|---|---|---|---|
| N/A | Ramp Length (in) | 97.0 | Yes | Ramp Slope (%) | 7.6 |
| No | Ramp Width (in) | 43.0 | No | Ramp XSlope (%) | 2.4 |

**Remove & Replace Curb Ramp With Two New Directional Ramps or Equivalent.**
