Access Compliance Report

Public Rights-of-Way

(Curb Ramps)

Intersection ID: 44907	Main Street: OAK_DR	Cross Street: OAKWINDS_CT	Location: NE
ADA ID: B9298749A3A4	Ramp Type: PerpDiag	Initial Pass/Fail: Fail	Overall Compliance: No
Codes/Mitigation Info/Possible Solution		Field Measurements/Component Compliance	
Severity Score: 58.75

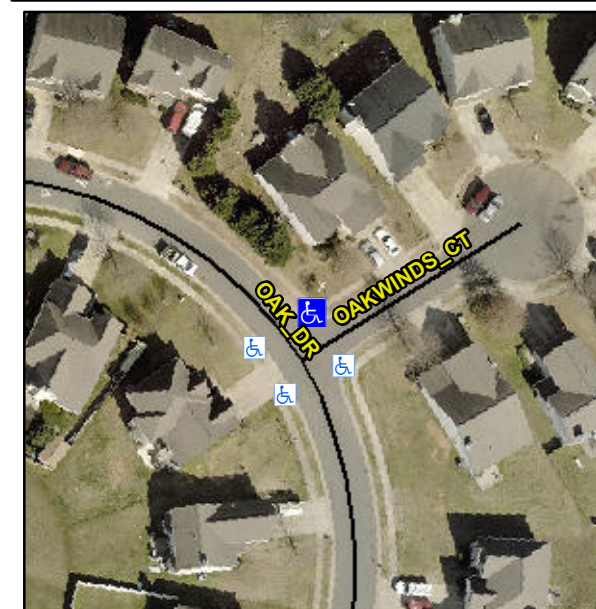
Compliance	Description	Data	Compliance	Description	Data
N/A	Ramp Length (in)	47.0	No	Ramp Slope (%)	20.0
No	Ramp Width (in)	36.0	No	Ramp XSlope (%)	9.9
N/A	Flare Type LT	N/A	N/A	Flare Type RT	N/A
N/A	Flare Slope LT (%)	N/A	N/A	Flare Slope RT (%)	N/A
N/A	Flare Traversable LT?	N/A	N/A	Flare Traversable RT?	N/A
N/A	Landing Length (in)	N/A	N/A	DWS Provided?	N/A
N/A	Landing Width (in)	N/A	N/A	DWS Contrast?	N/A
N/A	Landing Slope (%)	N/A	N/A	DWS Length (in)	N/A
N/A	Landing X Slope (%)	N/A	N/A	DWS Full Width?	N/A
N/A	Landing Curb? (Y/N)	N/A	N/A	DWS Offset (in)	N/A
N/A	Shared Landing?	N/A			
N/A	Gutter Ponding?	N/A	N/A	Gutter Slope (%)	N/A
N/A	Gutter Lip Ht (in)	N/A	N/A	Gutter X Slope (%)	N/A
N/A	Painted X Walk1?	No	N/A	Painted X Walk2?	No
	X Walk 1 Direction	To SW		X Walk 2 Direction	To SE
N/A	X Walk 1 Width (in)	N/A	N/A	X Walk 2 Width (in)	N/A
	X Walk 1 Slope (%)	4.5		X Walk 2 Slope (%)	2.4
	X Walk 1 X Slope (%)	6.0		X Walk 2 X Slope (%)	7.4

N/A	Ramp inside XWalk1?	N/A	N/A	Ramp inside XWalk2?	N/A
	Road Slope (%)	8.3	N/A	Clear Space?	N/A
	Road X Slope (%)	0.0	N/A	Clear Space to XWalk (in)	N/A
N/A	Any Obstructions?	N/A	N/A	Storm Grate/Utility Hazard?	N/A
	Obstruction Type			Storm Grate/Utility Type	
		N/A			N/A
			Yes	Surface Condition? (G/P)	Good

Remove & Replace Curb Ramp With Two New Directional Ramps or Equivalent.

Not Found, R304.5.1, R304.2.2, R304.5.3
