# Access Compliance Report

## Public Rights-of-Way

### (Curb Ramps)

Intersection ID: 43399	Main Street: SHOPTON_RD_WEST	Cross Street: CENTERLINE_DR	Location: W
ADA ID: B92B5C64115A	Ramp Type: PerpDiag	Initial Pass/Fail: Pass	Overall Compliance: No
Severity Score: 0			
Codes/Mitigation Info/Possible Solution		Field Measurements/Component Compliance

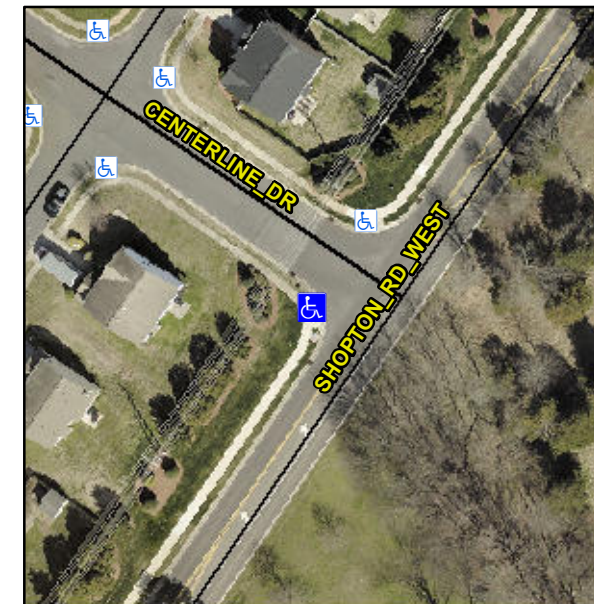
Compliance	Description	Data	Compliance	Description	Data
N/A	Ramp Length (in)	48.0	Yes	Ramp Slope (%)	5.8
Yes	Ramp Width (in)	48.0	Yes	Ramp XSlope (%)	1.2
N/A	Flare Type LT	Sloped	N/A	Flare Type RT	N/A
N/A	Flare Slope LT (%)	5.5	N/A	Flare Slope RT (%)	6.7
N/A	Flare Traversable LT?	No	N/A	Flare Traversable RT?	No
Yes	Landing Length (in)	58.0	Yes	DWS Provided?	Yes
No	Landing Width (in)	47.5	Yes	DWS Contrast?	Yes
Yes	Landing Slope (%)	1.3	Yes	DWS Length (in)	24.0
Yes	Landing X Slope (%)	1.5	Yes	DWS Full Width?	Yes
N/A	Landing Curb? (Y/N)	No	Yes	DWS Offset (in)	1.0
N/A	Shared Landing?	No			
Yes	Gutter Ponding?	No	Yes	Gutter Slope (%)	4.2
Yes	Gutter Lip Ht (in)	0.0	Yes	Gutter X Slope (%)	1.8
N/A	Painted X Walk1?	No	N/A	Painted X Walk2?	No
	X Walk 1 Direction	To SE		X Walk 2 Direction	To NE
N/A	X Walk 1 Width (in)	N/A	N/A	X Walk 2 Width (in)	N/A
	X Walk 1 Slope (%)	1.1		X Walk 2 Slope (%)	2.2
	X Walk 1 X Slope (%)	2.5		X Walk 2 X Slope (%)	1.5

N/A	Ramp inside XWalk1?	N/A	N/A	Ramp inside XWalk2?	N/A
	Road Slope (%)	1.9	N/A	Clear Space?	Yes
	Road X Slope (%)	1.7	N/A	Clear Space to XWalk (in)	N/A
Yes	Any Obstructions?	No	Yes	Storm Grate/Utility Hazard?	No
	Obstruction Type			Storm Grate/Utility Type	
		N/A			N/A
			Yes	Surface Condition? (G/P)	Good

**Remove & Replace Landing.**

**R304.2.1**
