# Access Compliance Report

## Public Rights-of-Way

### (Curb Ramps)

| Intersection ID: N/A | Main Street: SPEER_BV | Cross Street: ARBOR_LOOP_DR | Location: SW |

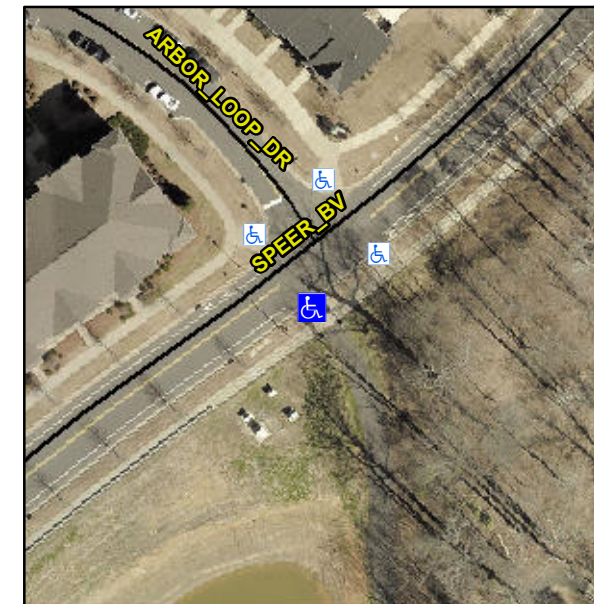
| Compliance | Description | Data | Compliance | Description | Data |
|---|---|---|---|---|---|
| N/A | Ramp Length (in) | 94.0 | No | Ramp Slope (%) | 8.4 |

**Remove & Replace Entire Ramp.**

**R304.2.2**

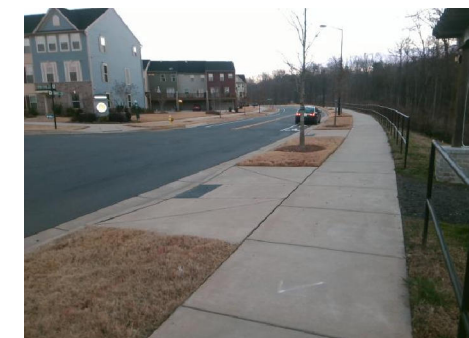
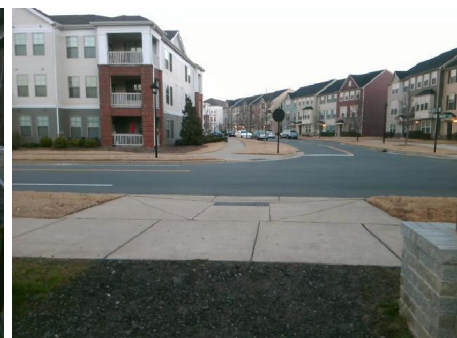
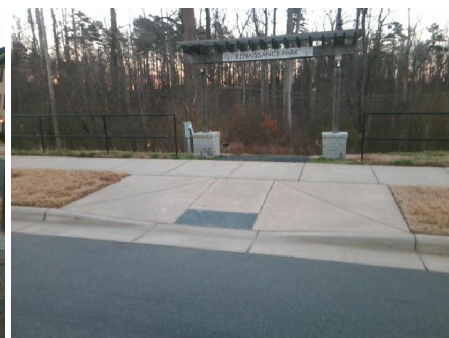
| Compliance | Description | Data | Compliance | Description | Data |
|---|---|---|---|---|---|
| | | | Yes | Surface Condition? (G/P) | Good |
