# Access Compliance Report

## Public Rights-of-Way

### (Curb Ramps)

| Intersection ID: 12056 | Main Street: ELLIOTT_ST | Cross Street: W_MOREHEAD_ST | Location: SE |

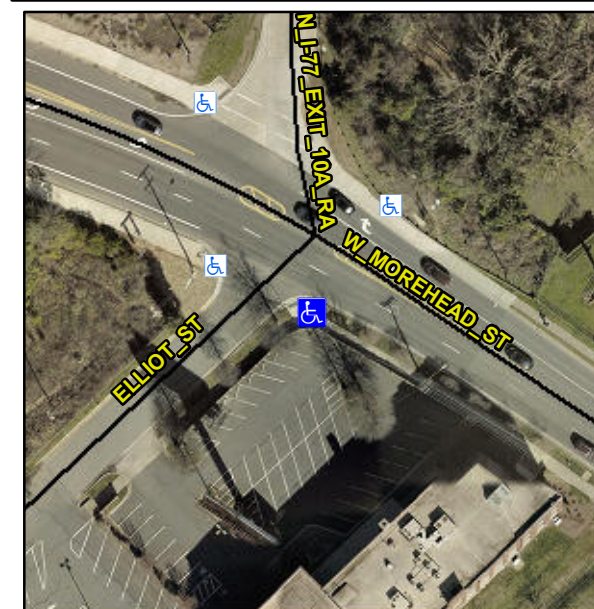
**LNDG LINE IS NOT PERP TO RAMP**

**R305.2**

| Compliance | Description | Data | Compliance | Description | Data |
|---|---|---|---|---|---|
| N/A | Landing Curb? (Y/N) | Yes | No | DWS Offset (in) | 3.5 |

**Remove & Replace Detectable Warning System.**

\$ 800.00
