Access Compliance Report Public Rights-of-Way (Curb Ramps)

Intersection ID: 29424 Main Street: BRADSTREET_COMMONS_WYCross Street: BRAWLEY_LN Location: SW

ADA ID: B93FD771F8D4 Ramp Type: Perp Initial Pass/Fail: Fail Overall Compliance: No Severity Score: 33.75

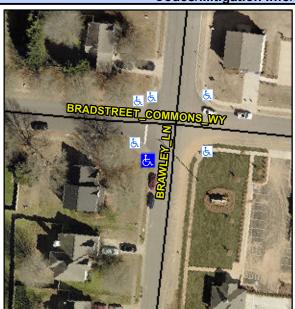
Comp	iance Description	Data	Comp	liance Description	Data
N/A	Ramp Length (in)	48.0	No	Ramp Slope (%)	13.7
No	Ramp Width (in)	47.5	Yes	Ramp XSlope (%)	0.9
N/A	Flare Type LT	N/A	N/A	Flare Type RT	N/A
N/A	Flare Slope LT (%)	N/A	N/A	Flare Slope RT (%)	N/A
N/A	Flare Traversable LT?	N/A	N/A	Flare Traversable RT?	N/A
N/A	Landing Length (in)	N/A	N/A	DWS Provided?	N/A
N/A	Landing Width (in)	N/A	N/A	DWS Contrast?	N/A
N/A	Landing Slope (%)	N/A	N/A	DWS Length (in)	N/A
N/A	Landing X Slope (%)	N/A	N/A	DWS Full Width?	N/A
N/A	Landing Curb? (Y/N)	N/A	N/A	DWS Offset (in)	N/A
N/A	Shared Landing?	N/A			
N/A	Gutter Ponding?	N/A	N/A	Gutter Slope (%)	N/A
N/A	Gutter Lip Ht (in)	0.5	N/A	Gutter X Slope (%)	N/A
N/A	Painted X Walk1?	No	N/A	Painted X Walk2?	N/A
	X Walk 1 Direction	To E		X Walk 2 Direction	N/A
N/A	X Walk 1 Width (in)	N/A	N/A	X Walk 2 Width (in)	N/A
	X Walk 1 Slope (%)	3.0		X Walk 2 Slope (%)	N/A
	X Walk 1 X Slope (%)	2.5		X Walk 2 X Slope (%)	N/A

Possible Solution	
Possible Solutions:	Compli
Remove & Replace Entire Ramp.	N/A
	No
	N/A
	N/A
	N/A
	N/A
Surveyor Notes:	N/A
N/A	N/A
	N/A
	N/A
	N/A
PROW/ADA:	N/A
R304.5.1, R304.2.2	N/A
	N/A
	N/A
	N/A
