Access Compliance Report

Public Rights-of-Way

(Curb Ramps)

Intersection ID: 10037049	Main Street: S_TRYON_ST	Cross Street: N/A	Location: SW
ADA ID: B9418150E95D	Ramp Type: BlendTrans2	Initial Pass/Fail: Fail	Overall Compliance: No
Severity Score: 25			
Codes/Mitigation Info/Possible Solution		Field Measurements/Component Compliance

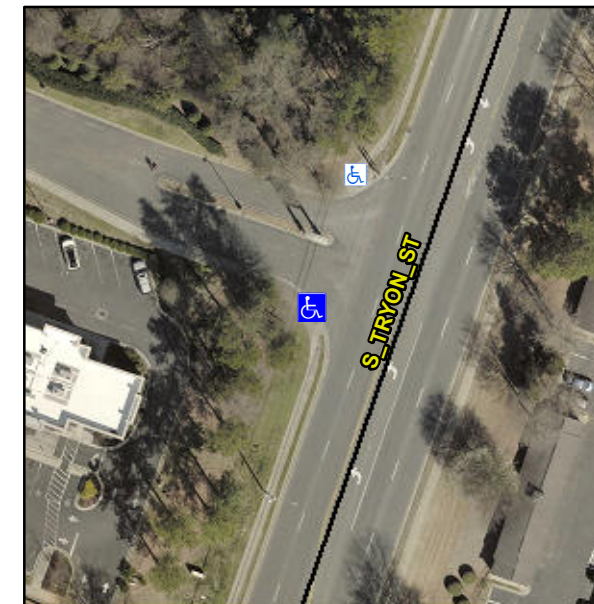
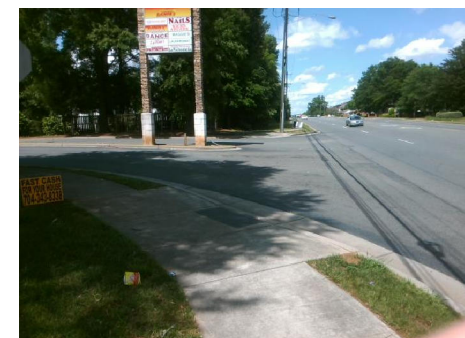
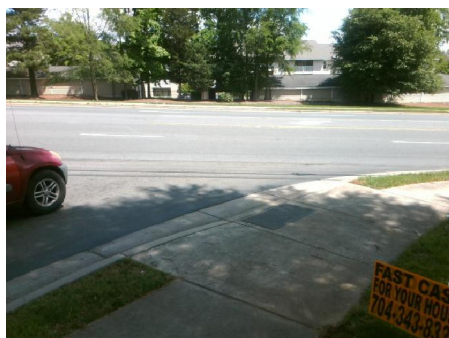
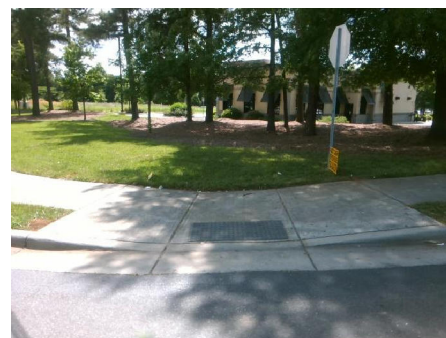
Compliance	Description	Data	Compliance	Description	Data
N/A	Ramp Length (in)	89.0	Yes	BlendTrans Slope (%)	2.8
Yes	Ramp Width (in)	57.0	No	BlendTrans XSlope (%)	8.2
N/A	Flare Type LT	N/A	N/A	Flare Type RT	N/A
N/A	Flare Slope LT (%)	N/A	N/A	Flare Slope RT (%)	N/A
N/A	Flare Traversable LT?	N/A	N/A	Flare Traversable RT?	N/A
N/A	Landing Length (in)	N/A	N/A	DWS Provided?	N/A
N/A	Landing Width (in)	N/A	N/A	DWS Contrast?	N/A
N/A	Landing Slope (%)	N/A	N/A	DWS Length (in)	N/A
N/A	Landing X Slope (%)	N/A	N/A	DWS Full Width?	N/A
N/A	Landing Curb? (Y/N)	N/A	N/A	DWS Offset (in)	N/A
N/A	Shared Landing?	N/A			
N/A	Gutter Ponding?	N/A	N/A	Gutter Slope (%)	N/A
N/A	Gutter Lip Ht (in)	N/A	N/A	Gutter X Slope (%)	N/A
N/A	Painted X Walk1?	No	N/A	Painted X Walk2?	No
	X Walk 1 Direction	To E		X Walk 2 Direction	To N
	X Walk 1 Width (in)	N/A		X Walk 2 Width (in)	N/A
	X Walk 1 Slope (%)	4.1		X Walk 2 Slope (%)	1.3
	X Walk 1 X Slope (%)	0.1		X Walk 2 X Slope (%)	2.9

N/A	Ramp inside XWalk1?	N/A	N/A	Ramp inside XWalk2?	N/A
	Road Slope (%)	4.4		Clear Space?	N/A
	Road X Slope (%)	1.6	N/A	Clear Space to XWalk (in)	N/A
N/A	Any Obstructions?	N/A	N/A	Storm Grate/Utility Hazard?	N/A
	Obstruction Type			Storm Grate/Utility Type	
		N/A			N/A
			Yes	Surface Condition? (G/P)	Good
			N/A	Curb Slope (%)	1.9

Possible Solutions:

Remove & Replace Curb Ramp With Two New Directional Ramps or Equivalent.

R304.5.3
