# Access Compliance Report

## Public Rights-of-Way

### (Curb Ramps)

| Intersection ID: 21451 | | Main Street: THORNCLIFF_DR | | Cross Street: WOODSTREAM_DR | | Location: SW | | | |

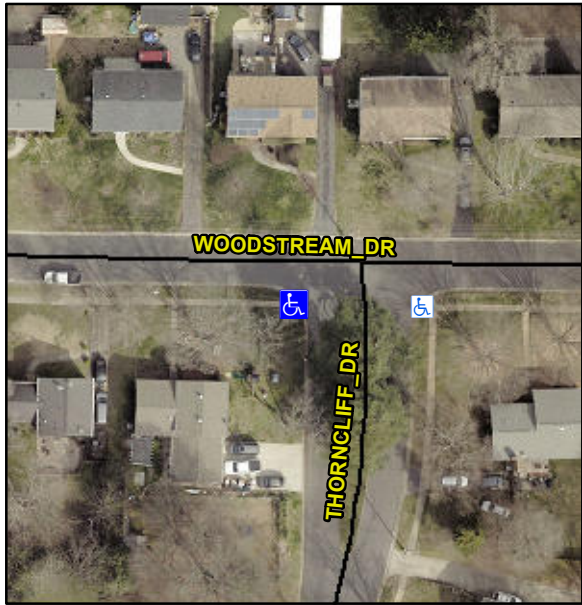
| ADA ID: B944CD33E23B | | Ramp Type: Directional1 | | Initial Pass/Fail: Pass | | Overall Compliance: No | | Severity Score: 7.5 | |
| | | | | No | Landing Width (in) | 46.5 | Yes | DWS Contrast? | Yes |
| | | | | No | Landing X Slope (%) | 2.1 | Yes | DWS Full Width? | Yes |
| | | | | No | Gutter Lip Ht (in) | 0.5 | No | Gutter X Slope (%) | 2.1 |

| <div></div> <div>Possible Solutions:<br/><br/><b>Remove &amp; Replace Landing.</b><br/><b>Remove &amp; Replace Gutter.</b></div> <div>Surveyor Notes:<br/><br/><b>N/A</b></div> <div>PROW/ADA:<br/><br/><b>R304.2.1, R304.5.3, R302.7.2</b></div> <div><div>Street 1 Name</div><div>THORNCLIFF DR</div><div>Stop Condition-Street 1</div><div>StopSign</div><div>Street 2 Name</div><div>N/A</div><div>Stop Condition-Street 2</div><div>N/A</div></div> | | | | Compliance | Description | Data | Compliance | Description | Data |
