# Access Compliance Report

## Public Rights-of-Way

### (Curb Ramps)

| Intersection ID: 30459 | Main Street: STEELE_MEADOW_RD | Cross Street: CADES_COVE_DR | Location: SW |

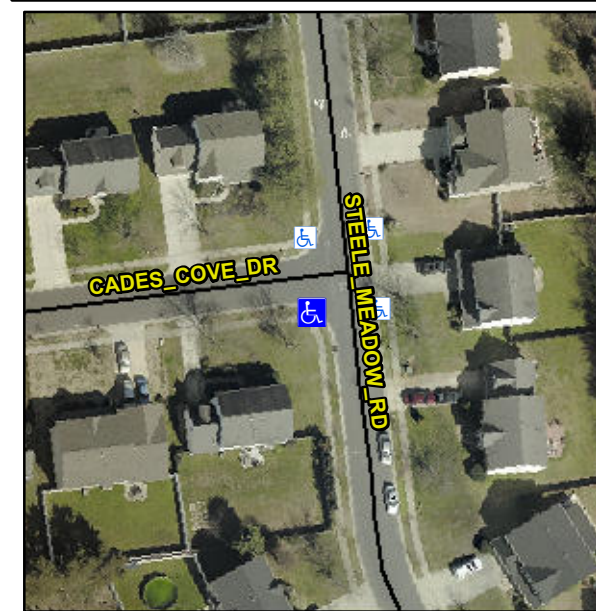
**R304.2.2-Perp, R304.3.2-Para, R305, R304.5.3**

| Compliance | Description | Data | Compliance | Description | Data |
|---|---|---|---|---|---|
| Yes | Landing Length (in) | 48.5 | No | DWS Provided? | No |
| No | Landing Slope (%) | 3.2 | N/A | DWS Length (in) | N/A |
| Yes | Gutter Lip Ht (in) | 0.0 | No | Gutter X Slope (%) | 2.2 |

**Remove & Replace Curb Ramp With Two New Directional Ramps or Equivalent. Remove & Replace Gutter.**

Total Cost: \$ 3950.00
