## Access Compliance Report Public Rights-of-Way (Curb Ramps)

Intersection ID: 29503 Main Street: SILABERT\_AV Cross Street: ROSS\_MOORE\_AV Location: N

ADA ID: B949E78290DB Ramp Type: BlendTrans1 Initial Pass/Fail: Fail Overall Compliance: No Severity Score: 21.25

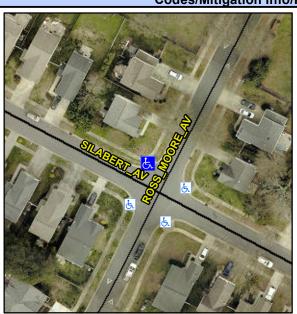
Not Found, R304.5.1, R304.5.3

Comp	npliance Description Data Compliance Description				Data
	N/A	Ramp Length (in)	83.5	Yes	BlendTrans Slope (%)	3.8
	No No	Ramp Width (in)	44.0	No	BlendTrans XSlope (%)	5.0 6.4
	N/A	. ,	44.0 N/A	N/A	,	N/A
		Flare Stone LT (%)			Flare Type RT	
	N/A	Flare Slope LT (%)	N/A	N/A	Flare Slope RT (%)	N/A
	N/A	Flare Traversable LT?	N/A	N/A	Flare Traversable RT?	N/A
	N/A	Landing Length (in)	N/A	N/A	DWS Provided?	N/A
	N/A	Landing Width (in)	N/A	N/A	DWS Contrast?	N/A
	N/A	Landing Slope (%)	N/A	N/A	DWS Length (in)	N/A
	N/A	Landing X Slope (%)	N/A	N/A	DWS Full Width?	N/A
	N/A	Landing Curb? (Y/N)	N/A	N/A	DWS Offset (in)	N/A
	N/A	Shared Landing?	N/A			
	N/A	Gutter Ponding?	N/A	N/A	Gutter Slope (%)	N/A
	N/A	Gutter Lip Ht (in)	N/A	N/A	Gutter X Slope (%)	N/A
	N/A	Painted X Walk1?	No	N/A	Painted X Walk2?	No
		X Walk 1 Direction	To SW		X Walk 2 Direction	To SE
		X Walk 1 Width (in)	N/A		X Walk 2 Width (in)	N/A
		X Walk 1 Slope (%)	2.0		X Walk 2 Slope (%)	5.2

X Walk 1 X Slope (%)	3.7		X Walk 2 X Slope (%)	5.3
	N/A	Ramp inside XWalk1?	N/A	N/A	Ramp inside XWalk2?	N/A
		Road Slope (%)	7.9		Clear Space?	N/A
		Road X Slope (%)	3.0	N/A	Clear Space to XWalk (in)	N/A
	N/A	Any Obstructions?	N/A	N/A	Storm Grate/Utility Hazard?	N/A
		Obstruction Type			Storm Grate/Utility Type	
			N/A			N/A
				Yes	Surface Condition? (G/P)	Good
May.				No	Curb Slope (%)	11.8

Remove & Replace Curb Ramp With Two New Directional Ramps or Equivalent.
