Access Compliance Report

Public Rights-of-Way

(Curb Ramps)

Intersection ID: 10038888	Main Street: STINSON_CT	Cross Street: N/A	Location: E
ADA ID: B95845E0D9C8	Ramp Type: Perp	Initial Pass/Fail: Fail	Overall Compliance: No
		Severity Score: 10

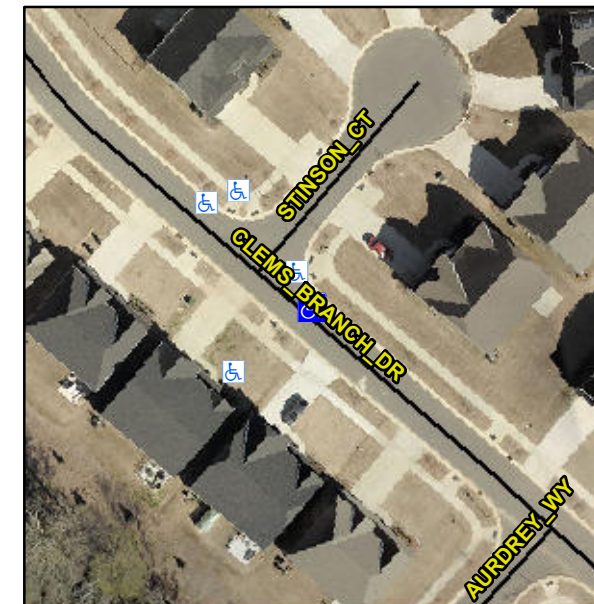
R304.5.1, R304.5.3

Compliance	Description	Data	Compliance	Description	Data
N/A	Ramp Length (in)	96.0	Yes	Ramp Slope (%)	5.1
No	Ramp Width (in)	47.0	No	Ramp XSlope (%)	3.5
N/A	Flare Type LT	N/A	N/A	Flare Type RT	N/A
N/A	Flare Slope LT (%)	N/A	N/A	Flare Slope RT (%)	N/A
N/A	Flare Traversable LT?	N/A	N/A	Flare Traversable RT?	N/A
N/A	Landing Length (in)	N/A	N/A	DWS Provided?	N/A
N/A	Landing Width (in)	N/A	N/A	DWS Contrast?	N/A
N/A	Landing Slope (%)	N/A	N/A	DWS Length (in)	N/A
N/A	Landing X Slope (%)	N/A	N/A	DWS Full Width?	N/A
N/A	Landing Curb? (Y/N)	N/A	N/A	DWS Offset (in)	N/A
N/A	Shared Landing?	N/A			
N/A	Gutter Ponding?	N/A	N/A	Gutter Slope (%)	N/A
N/A	Gutter Lip Ht (in)	N/A	N/A	Gutter X Slope (%)	N/A
N/A	Painted X Walk1?	No	N/A	Painted X Walk2?	N/A
	X Walk 1 Direction	To SW		X Walk 2 Direction	N/A
N/A	X Walk 1 Width (in)	N/A	N/A	X Walk 2 Width (in)	N/A
	X Walk 1 Slope (%)	4.6		X Walk 2 Slope (%)	N/A
	X Walk 1 X Slope (%)	2.9		X Walk 2 X Slope (%)	N/A

Remove & Replace Entire Ramp.
