## Access Compliance Report Public Rights-of-Way (Curb Ramps)

Intersection ID: 10023893 Main Street: COMMUNITY\_HOUSE\_RD Cross Street: N/A Location: N

ADA ID: B95C2DA608D5 Ramp Type: PerpDiag Initial Pass/Fail: Fail Overall Compliance: No Severity Score: 8.75

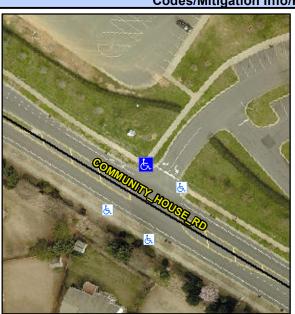
Field Measurements/Component Compliance					
Compliance Description		Data	Comp	liance Description	Data
N/A	Ramp Length (in)	76.0	Yes	Ramp Slope (%)	6.9
No	Ramp Width (in)	38.0	Yes	Ramp XSlope (%)	1.3
N/A	Flare Type LT	N/A	N/A	Flare Type RT	N/A
N/A	Flare Slope LT (%)	N/A	N/A	Flare Slope RT (%)	N/A
N/A	Flare Traversable LT?	N/A	N/A	Flare Traversable RT?	N/A
N/A	Landing Length (in)	N/A	N/A	DWS Provided?	N/A
N/A	Landing Width (in)	N/A	N/A	DWS Contrast?	N/A
N/A	Landing Slope (%)	N/A	N/A	DWS Length (in)	N/A
N/A	Landing X Slope (%)	N/A	N/A	DWS Full Width?	N/A
N/A	Landing Curb? (Y/N)	N/A	N/A	DWS Offset (in)	N/A
N/A	Shared Landing?	N/A			
N/A	Gutter Ponding?	N/A	N/A	Gutter Slope (%)	N/A
N/A	Gutter Lip Ht (in)	N/A	N/A	Gutter X Slope (%)	N/A
N/A	Painted X Walk1?	No	N/A	Painted X Walk2?	No
	X Walk 1 Direction	To SW		X Walk 2 Direction	To SE
N/A	X Walk 1 Width (in)	N/A	N/A	X Walk 2 Width (in)	N/A
	X Walk 1 Slope (%)	1.5		X Walk 2 Slope (%)	0.9

X Walk 1 X Slope (%)	0.6		X Walk 2 X Slope (%)	0.0
N/A	Ramp inside XWalk1?	N/A	N/A	Ramp inside XWalk2?	N/A
	Road Slope (%)	1.2	N/A	Clear Space?	N/A
	Road X Slope (%)	1.7	N/A	Clear Space to XWalk (in)	N/A
N/A	Any Obstructions?	N/A	N/A	Storm Grate/Utility Hazard?	N/A
	Obstruction Type			Storm Grate/Utility Type	
		N/A			N/A
			Yes	Surface Condition? (G/P)	Good
TE.	A STATE OF THE STA

Possible Solutions:

Remove & Replace Curb Ramp With
Two New Directional Ramps or
Equivalent.
