# Access Compliance Report

## Public Rights-of-Way

### (Curb Ramps)

Intersection ID: 16112	Main Street: ANSON_ST	Cross Street: HARTFORD_AV	Location: N
ADA ID: B95D3ED7AC28	Ramp Type: Directional1	Initial Pass/Fail: Pass	Overall Compliance: No
Codes/Mitigation Info/Possible Solution		Field Measurements/Component Compliance	
Severity Score: 0

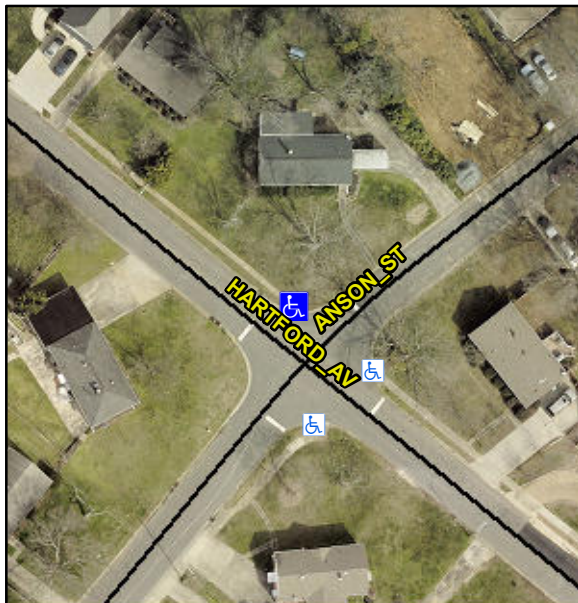
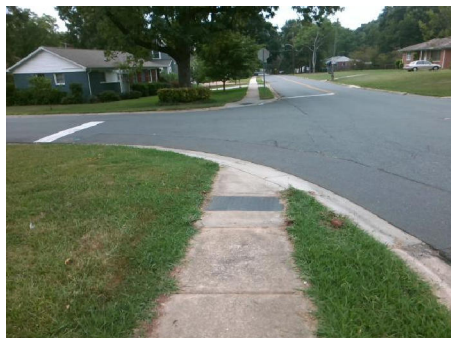
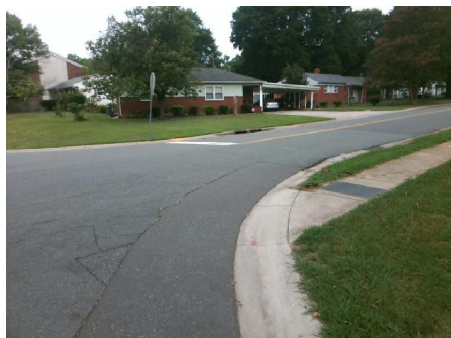
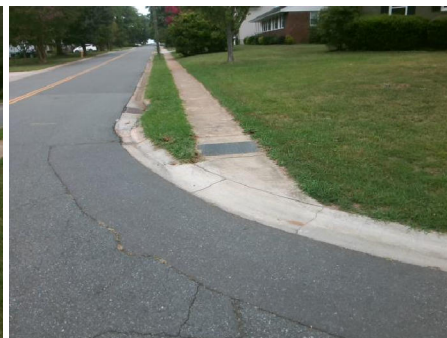
**Not Found, R304.2.2-Perp, R304.3.2-  
Para, R304.5.2, R305.2, R304.5.3**

Compliance	Description	Data	Compliance	Description	Data
N/A	Ramp Length (in)	30.0	No	Grade Break?	No
Yes	Ramp Width (in)	48.0	N/A	Grade Break Slope (%)	5.3
Yes	Ramp Slope (%)	6.4	N/A	Grade Break XSlope (%)	0.6
Yes	Ramp XSlope (%)	1.8			
N/A	Flare Type LT	N/A	N/A	Flare Type RT	N/A
N/A	Flare Slope LT (%)	N/A	N/A	Flare Slope RT (%)	N/A
N/A	Flare Traversable LT?	N/A	N/A	Flare Traversable RT?	N/A
Yes	Landing Length (in)	48.0	Yes	DWS Provided?	Yes
Yes	Landing Width (in)	48.0	Yes	DWS Contrast?	Yes
No	Landing Slope (%)	4.4	Yes	DWS Length (in)	24.0
Yes	Landing X Slope (%)	1.4	Yes	DWS Full Width?	Yes
N/A	Landing Curb? (Y/N)	N/A	No	DWS Offset LT (in)	10.0
N/A	Shared Landing?	No	No	DWS Offset RT (in)	80.0
Yes	Gutter Ponding?	No	Yes	Gutter Slope (%)	1.2
Yes	Gutter Lip Ht (in)	0.0	No	Gutter X Slope (%)	3.8
N/A	Painted X Walk1?	No		Road Slope (%)	3.0
	X Walk 1 Direction	To SE		Road X Slope (%)	4.7
	X Walk 1 Width (in)	N/A		Clear Space?	Yes

X Walk 1 Slope (%)	3.0	N/A	Clear Space to XWalk (in)	N/A
	X Walk 1 X Slope (%)	4.7	Yes	Storm Grate/Utility Hazard?	No
N/A	Ramp inside XWalk1?	N/A		Storm Grate/Utility Type	
Yes	Any Obstructions?	No			N/A
	Obstruction Type		Yes	Surface Condition? (G/P)	Good
			N/A	Curb Slope (%)	23.8

Possible Solutions:

**Remove & Replace Entire Ramp.  
Remove & Replace Gutter.**
