# Access Compliance Report

## Public Rights-of-Way

### (Curb Ramps)

| Intersection ID: 2549 | Main Street: BEARDSLEY_DR | Cross Street: MCCHESENEY_DR | Location: | N |

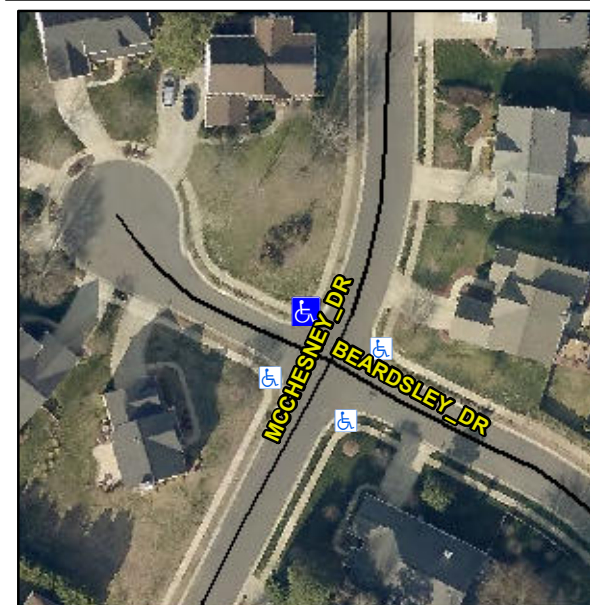
| ADA ID: B96319890575 | Ramp Type: PerpDiag | Initial Pass/Fail: Pass | Overall Compliance: No | Severity Score: 5.25 |

**R304.5.3, R304.2.2-Perp, R304.3.2-Para, R304.2.3, R305.2**

| Compliance | Description | Data | Compliance | Description | Data |
|---|---|---|---|---|---|
| Yes | Ramp Width (in) | 48.0 | No | Ramp XSlope (%) | 2.6 |
| No | Landing Slope (%) | 2.7 | Yes | DWS Length (in) | 24.0 |
| No | Landing X Slope (%) | 4.1 | Yes | DWS Full Width? | Yes |
| N/A | Landing Curb? (Y/N) | No | No | DWS Offset (in) | 3.5 |
| Yes | Gutter Lip Ht (in) | 0.0 | No | Gutter X Slope (%) | 2.3 |

**Remove & Replace Curb Ramp With Two New Directional Ramps or Equivalent. Remove & Replace Gutter.**

Total Cost: \$ **3950.00**
