# Access Compliance Report

## Public Rights-of-Way

### (Curb Ramps)

Intersection ID: 31809	Main Street: CRANE_POINT_DR	Cross Street: OSPREY_WATCH_CT	Location: SE
ADA ID: B963A8D63115	Ramp Type: PerpDiag	Initial Pass/Fail: Fail	Overall Compliance: No
Severity Score: 8.75			
Codes/Mitigation Info/Possible Solution		Field Measurements/Component Compliance

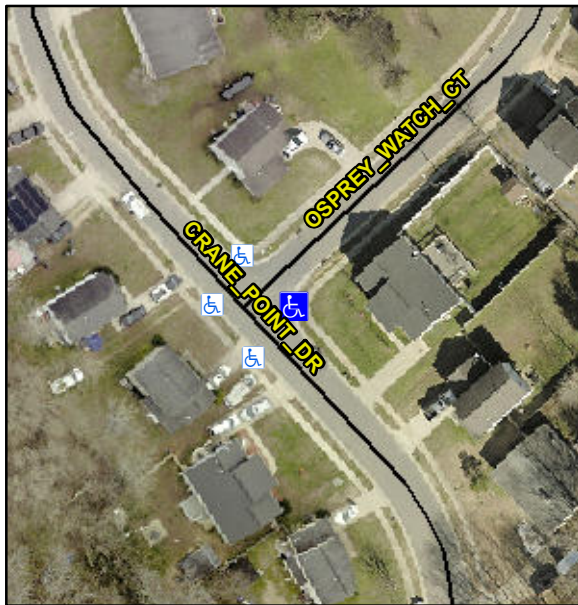
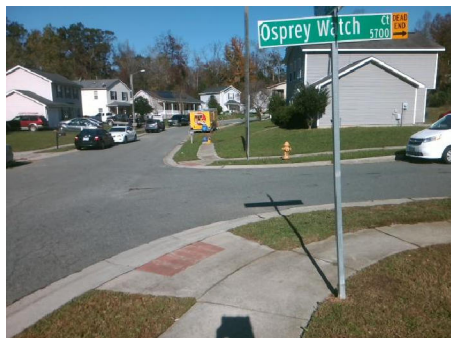
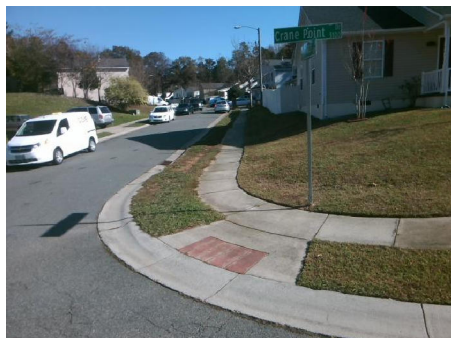
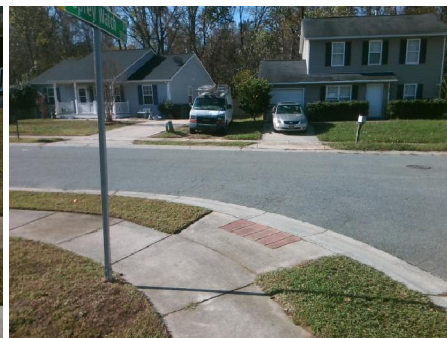
**Not Found, R304.5.1**

Compliance	Description	Data	Compliance	Description	Data
N/A	Ramp Length (in)	47.0	Yes	Ramp Slope (%)	5.1
No	Ramp Width (in)	44.0	Yes	Ramp XSlope (%)	0.5
N/A	Flare Type LT	N/A	N/A	Flare Type RT	N/A
N/A	Flare Slope LT (%)	N/A	N/A	Flare Slope RT (%)	N/A
N/A	Flare Traversable LT?	N/A	N/A	Flare Traversable RT?	N/A
N/A	Landing Length (in)	N/A	N/A	DWS Provided?	N/A
N/A	Landing Width (in)	N/A	N/A	DWS Contrast?	N/A
N/A	Landing Slope (%)	N/A	N/A	DWS Length (in)	N/A
N/A	Landing X Slope (%)	N/A	N/A	DWS Full Width?	N/A
N/A	Landing Curb? (Y/N)	N/A	N/A	DWS Offset (in)	N/A
N/A	Shared Landing?	N/A			
N/A	Gutter Ponding?	N/A	N/A	Gutter Slope (%)	N/A
N/A	Gutter Lip Ht (in)	N/A	N/A	Gutter X Slope (%)	N/A
N/A	Painted X Walk1?	No	N/A	Painted X Walk2?	No
	X Walk 1 Direction	To NW		X Walk 2 Direction	To SW
N/A	X Walk 1 Width (in)	N/A	N/A	X Walk 2 Width (in)	N/A
	X Walk 1 Slope (%)	2.3		X Walk 2 Slope (%)	2.4
	X Walk 1 X Slope (%)	2.0		X Walk 2 X Slope (%)	2.9

N/A	Ramp inside XWalk1?	N/A	N/A	Ramp inside XWalk2?	N/A
	Road Slope (%)	1.5	N/A	Clear Space?	N/A
	Road X Slope (%)	1.0	N/A	Clear Space to XWalk (in)	N/A
N/A	Any Obstructions?	N/A	N/A	Storm Grate/Utility Hazard?	N/A
	Obstruction Type			Storm Grate/Utility Type	
		N/A			N/A
		Yes		Surface Condition? (G/P)	Good

**Remove & Replace Curb Ramp With Two New Directional Ramps or Equivalent.**
