# Access Compliance Report

## Public Rights-of-Way

### (Curb Ramps)

Intersection ID: 4031	Main Street: MALLARD_CREEK_RD	Cross Street: DRIWOOD_CT	Location:	N
ADA ID: B96B9FE3DEE1	Ramp Type: Perp	Initial Pass/Fail: Fail	Overall Compliance: No	Severity Score: 25

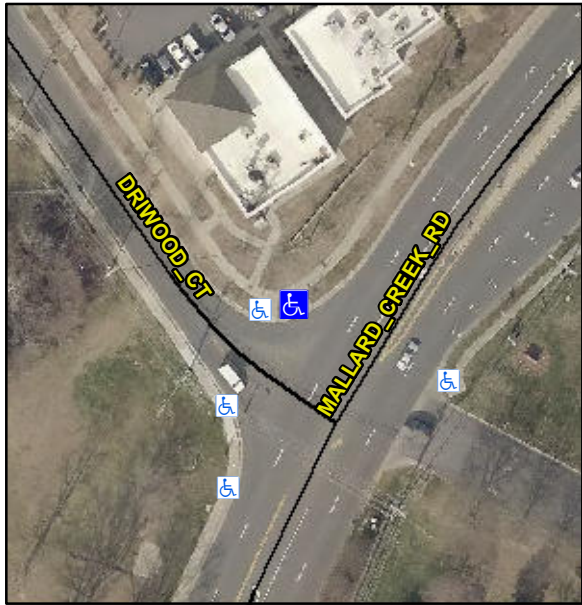
Possible Solutions:		Compliance	Description	Data	Compliance	Description	Data
	Remove & Replace Entire Ramp.		N/A	Ramp Length (in)	95.0	Yes	Ramp Slope (%)	5.5
			Yes	Ramp Width (in)	48.0	No	Ramp XSlope (%)	9.5
			N/A	Flare Type LT	N/A	N/A	Flare Type RT	N/A
			N/A	Flare Slope LT (%)	N/A	N/A	Flare Slope RT (%)	N/A
			N/A	Flare Traversable LT?	N/A	N/A	Flare Traversable RT?	N/A
			N/A	Landing Length (in)	N/A	N/A	DWS Provided?	N/A
			N/A	Landing Width (in)	N/A	N/A	DWS Contrast?	N/A
			N/A	Landing Slope (%)	N/A	N/A	DWS Length (in)	N/A
			N/A	Landing X Slope (%)	N/A	N/A	DWS Full Width?	N/A
Surveyor Notes:  N/A			N/A	Landing Curb? (Y/N)	N/A	N/A	DWS Offset (in)	N/A
			N/A	Shared Landing?	N/A			
			N/A	Gutter Ponding?	N/A	N/A	Gutter Slope (%)	N/A
			N/A	Gutter Lip Ht (in)	N/A	N/A	Gutter X Slope (%)	N/A
			N/A	Painted X Walk1?	No	N/A	Painted X Walk2?	N/A

X Walk 1 Direction	To SE		X Walk 2 Direction	N/A
			N/A	X Walk 1 Width (in)	N/A	N/A	X Walk 2 Width (in)	N/A
				X Walk 1 Slope (%)	9.7		X Walk 2 Slope (%)	N/A
				X Walk 1 X Slope (%)	1.2		X Walk 2 X Slope (%)	N/A
			N/A	Ramp inside XWalk1?	N/A	N/A	Ramp inside XWalk2?	N/A
PROW/ADA:  Not Found, R304.5.3				Road Slope (%)	N/A	N/A	Clear Space?	N/A
				Road X Slope (%)	N/A	N/A	Clear Space to XWalk (in)	N/A
			N/A	Any Obstructions?	N/A	N/A	Storm Grate/Utility Hazard?	N/A
				Obstruction Type			Storm Grate/Utility Type	
					N/A			N/A
						Yes	Surface Condition? (G/P)	Good
Total Cost:			\$	1850.00
