Access Compliance Report

Public Rights-of-Way

(Curb Ramps)

Intersection ID: 53165	Main Street: DIXIE_RIVER_RD	Cross Street: N/A	Location: NE
ADA ID: B9759F549935	Ramp Type: Perp	Initial Pass/Fail: Fail	Overall Compliance: No
Severity Score: 1.25			
Codes/Mitigation Info/Possible Solution		Field Measurements/Component Compliance

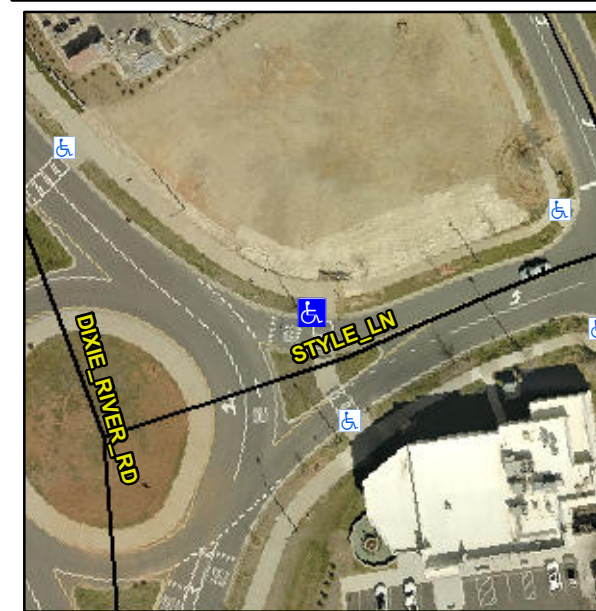
Not Found, R304.5.3

Compliance	Description	Data	Compliance	Description	Data
N/A	Ramp Length (in)	94.0	Yes	Ramp Slope (%)	6.1
Yes	Ramp Width (in)	48.0	No	Ramp XSlope (%)	3.1
N/A	Flare Type LT	N/A	N/A	Flare Type RT	N/A
N/A	Flare Slope LT (%)	N/A	N/A	Flare Slope RT (%)	N/A
N/A	Flare Traversable LT?	N/A	N/A	Flare Traversable RT?	N/A
N/A	Landing Length (in)	N/A	N/A	DWS Provided?	N/A
N/A	Landing Width (in)	N/A	N/A	DWS Contrast?	N/A
N/A	Landing Slope (%)	N/A	N/A	DWS Length (in)	N/A
N/A	Landing X Slope (%)	N/A	N/A	DWS Full Width?	N/A
N/A	Landing Curb? (Y/N)	N/A	N/A	DWS Offset (in)	N/A
N/A	Shared Landing?	N/A			
N/A	Gutter Ponding?	N/A	N/A	Gutter Slope (%)	N/A
N/A	Gutter Lip Ht (in)	N/A	N/A	Gutter X Slope (%)	N/A
N/A	Painted X Walk1?	Yes	N/A	Painted X Walk2?	N/A
	X Walk 1 Direction	To S		X Walk 2 Direction	N/A
N/A	X Walk 1 Width (in)	113.0	N/A	X Walk 2 Width (in)	N/A
	X Walk 1 Slope (%)	1.5		X Walk 2 Slope (%)	N/A
	X Walk 1 X Slope (%)	3.1		X Walk 2 X Slope (%)	N/A

N/A	Ramp inside XWalk1?	Yes	N/A	Ramp inside XWalk2?	N/A
	Road Slope (%)	N/A	N/A	Clear Space?	N/A
	Road X Slope (%)	N/A	N/A	Clear Space to XWalk (in)	N/A
N/A	Any Obstructions?	N/A	N/A	Storm Grate/Utility Hazard?	N/A
	Obstruction Type			Storm Grate/Utility Type	
		N/A			N/A
			Yes	Surface Condition? (G/P)	Good

Remove & Replace Entire Ramp.
