# Access Compliance Report

## Public Rights-of-Way

### (Curb Ramps)

Intersection ID: 29961	Main Street: CANIPE_DR	Cross Street: HOLLOW_RIDGE_LN	Location: NE
ADA ID: B97A3461DB2F	Ramp Type: PerpDiag	Initial Pass/Fail: Fail	Overall Compliance: No
Severity Score: 21.25			
Codes/Mitigation Info/Possible Solution		Field Measurements/Component Compliance

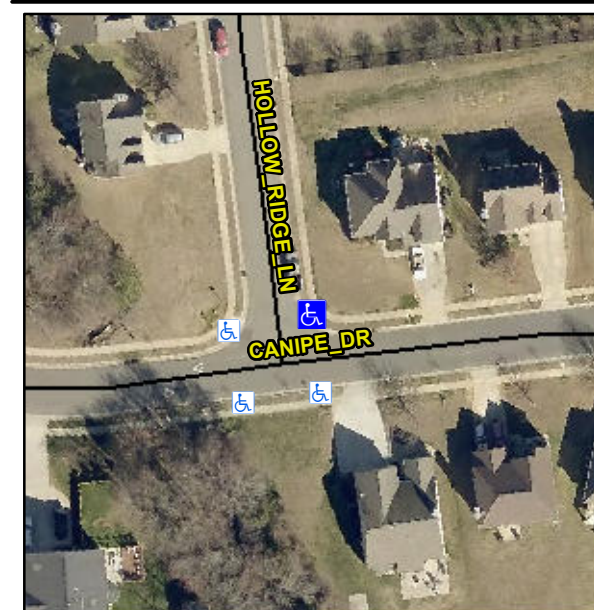
**Not Found, R304.5.1, R304.2.2**

Compliance	Description	Data	Compliance	Description	Data
N/A	Ramp Length (in)	43.5	No	Ramp Slope (%)	9.3
No	Ramp Width (in)	41.5	Yes	Ramp XSlope (%)	0.4
N/A	Flare Type LT	N/A	N/A	Flare Type RT	N/A
N/A	Flare Slope LT (%)	N/A	N/A	Flare Slope RT (%)	N/A
N/A	Flare Traversable LT?	N/A	N/A	Flare Traversable RT?	N/A
N/A	Landing Length (in)	N/A	N/A	DWS Provided?	N/A
N/A	Landing Width (in)	N/A	N/A	DWS Contrast?	N/A
N/A	Landing Slope (%)	N/A	N/A	DWS Length (in)	N/A
N/A	Landing X Slope (%)	N/A	N/A	DWS Full Width?	N/A
N/A	Landing Curb? (Y/N)	N/A	N/A	DWS Offset (in)	N/A
N/A	Shared Landing?	N/A			
N/A	Gutter Ponding?	N/A	N/A	Gutter Slope (%)	N/A
N/A	Gutter Lip Ht (in)	N/A	N/A	Gutter X Slope (%)	N/A
N/A	Painted X Walk1?	No	N/A	Painted X Walk2?	No
	X Walk 1 Direction	To W		X Walk 2 Direction	To S
N/A	X Walk 1 Width (in)	N/A	N/A	X Walk 2 Width (in)	N/A
	X Walk 1 Slope (%)	4.9		X Walk 2 Slope (%)	3.9
	X Walk 1 X Slope (%)	3.7		X Walk 2 X Slope (%)	2.4

N/A	Ramp inside XWalk1?	N/A	N/A	Ramp inside XWalk2?	N/A
	Road Slope (%)	0.5	N/A	Clear Space?	N/A
	Road X Slope (%)	4.7	N/A	Clear Space to XWalk (in)	N/A
N/A	Any Obstructions?	N/A	N/A	Storm Grate/Utility Hazard?	N/A
	Obstruction Type			Storm Grate/Utility Type	
		N/A			N/A
			Yes	Surface Condition? (G/P)	Good

**Remove & Replace Curb Ramp With Two New Directional Ramps or Equivalent.**
