Access Compliance Report

Public Rights-of-Way

(Curb Ramps)

| Intersection ID: 10395 | Main Street: N_GRAHAM_ST | Cross Street: SYLVANIA_AV | Location: E |

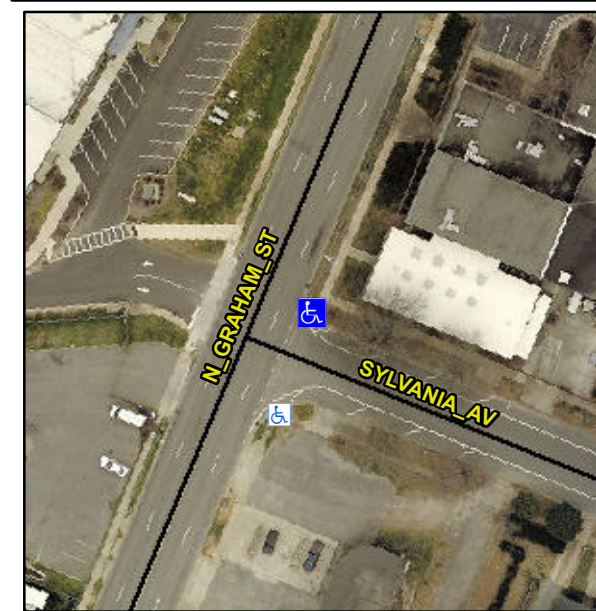
| ADA ID: B9850C5596FE | Ramp Type: Perp | Initial Pass/Fail: Fail | Overall Compliance: No |

R304.5.3

| Compliance | Description | Data | Compliance | Description | Data |
|---|---|---|---|---|---|
| Yes | Ramp Width (in) | 55.5 | No | Ramp XSlope (%) | 3.1 |
| N/A | Gutter Ponding? | Yes | N/A | Gutter Slope (%) | N/A |

Remove & Replace Entire Ramp.

\$ 1850.00
