Access Compliance Report

Public Rights-of-Way

(Curb Ramps)

Intersection ID: 4387	Main Street: BROOKSTONE_DR	Cross Street: LINDEN_BERRY_LN	Location:	N
ADA ID: B9860F716142	Ramp Type: Perp	Initial Pass/Fail: Fail	Overall Compliance: No	Severity Score: 25
Codes/Mitigation Info/Possible Solution		Field Measurements/Component Compliance

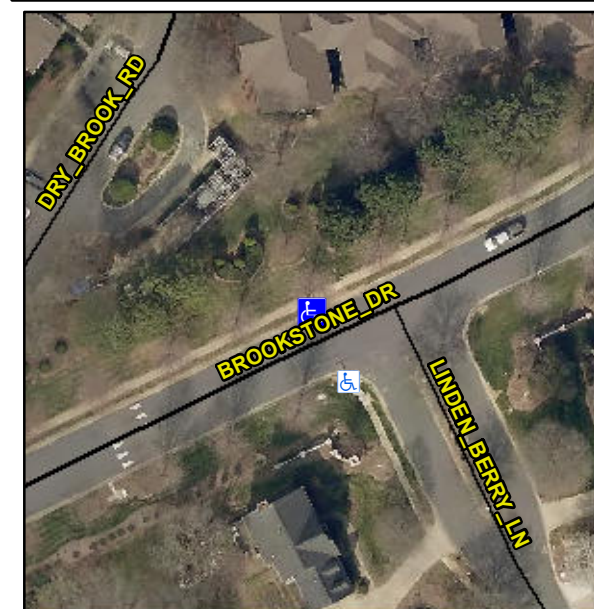
Not Found, R304.2.2

Compliance	Description	Data	Compliance	Description	Data
N/A	Ramp Length (in)	50.5	No	Ramp Slope (%)	12.4
Yes	Ramp Width (in)	55.0	Yes	Ramp XSlope (%)	0.5
N/A	Flare Type LT	N/A	N/A	Flare Type RT	N/A
N/A	Flare Slope LT (%)	N/A	N/A	Flare Slope RT (%)	N/A
N/A	Flare Traversable LT?	N/A	N/A	Flare Traversable RT?	N/A
N/A	Landing Length (in)	N/A	N/A	DWS Provided?	N/A
N/A	Landing Width (in)	N/A	N/A	DWS Contrast?	N/A
N/A	Landing Slope (%)	N/A	N/A	DWS Length (in)	N/A
N/A	Landing X Slope (%)	N/A	N/A	DWS Full Width?	N/A
N/A	Landing Curb? (Y/N)	N/A	N/A	DWS Offset (in)	N/A
N/A	Shared Landing?	N/A			
N/A	Gutter Ponding?	N/A	N/A	Gutter Slope (%)	N/A
N/A	Gutter Lip Ht (in)	N/A	N/A	Gutter X Slope (%)	N/A
N/A	Painted X Walk1?	No	N/A	Painted X Walk2?	N/A
	X Walk 1 Direction	To S		X Walk 2 Direction	N/A
N/A	X Walk 1 Width (in)	N/A	N/A	X Walk 2 Width (in)	N/A
	X Walk 1 Slope (%)	3.0		X Walk 2 Slope (%)	N/A
	X Walk 1 X Slope (%)	0.1		X Walk 2 X Slope (%)	N/A

Remove & Replace Entire Ramp.
