# Access Compliance Report

## Public Rights-of-Way

### (Curb Ramps)

Intersection ID: 47881	Main Street: PINEHAVEN_CT	Cross Street: PLAZA_MEADOW_DR	Location: NW
ADA ID: B990DDCAA462	Ramp Type: Perp	Initial Pass/Fail: Fail	Overall Compliance: No
Severity Score: 13.75			
Codes/Mitigation Info/Possible Solution		Field Measurements/Component Compliance

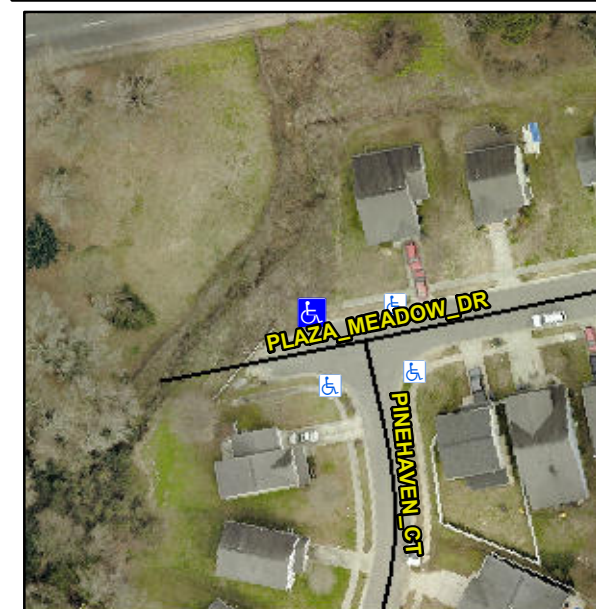
PROW/ADA:

**Not Found, R304.2.2, R304.5.3**

Compliance	Description	Data	Compliance	Description	Data
N/A	Ramp Length (in)	49.0	No	Ramp Slope (%)	10.7
Yes	Ramp Width (in)	48.0	No	Ramp XSlope (%)	2.9
N/A	Flare Type LT	N/A	N/A	Flare Type RT	N/A
N/A	Flare Slope LT (%)	N/A	N/A	Flare Slope RT (%)	N/A
N/A	Flare Traversable LT?	N/A	N/A	Flare Traversable RT?	N/A
N/A	Landing Length (in)	N/A	N/A	DWS Provided?	N/A
N/A	Landing Width (in)	N/A	N/A	DWS Contrast?	N/A
N/A	Landing Slope (%)	N/A	N/A	DWS Length (in)	N/A
N/A	Landing X Slope (%)	N/A	N/A	DWS Full Width?	N/A
N/A	Landing Curb? (Y/N)	N/A	N/A	DWS Offset (in)	N/A
N/A	Shared Landing?	N/A			
N/A	Gutter Ponding?	N/A	N/A	Gutter Slope (%)	N/A
N/A	Gutter Lip Ht (in)	N/A	N/A	Gutter X Slope (%)	N/A
N/A	Painted X Walk1?	No	N/A	Painted X Walk2?	N/A
	X Walk 1 Direction	To S		X Walk 2 Direction	N/A
N/A	X Walk 1 Width (in)	N/A	N/A	X Walk 2 Width (in)	N/A
	X Walk 1 Slope (%)	3.8		X Walk 2 Slope (%)	N/A
	X Walk 1 X Slope (%)	2.1		X Walk 2 X Slope (%)	N/A

N/A	Ramp inside XWalk1?	N/A	N/A	Ramp inside XWalk2?	N/A
	Road Slope (%)	N/A	N/A	Clear Space?	N/A
	Road X Slope (%)	N/A	N/A	Clear Space to XWalk (in)	N/A
N/A	Any Obstructions?	N/A	N/A	Storm Grate/Utility Hazard?	N/A
	Obstruction Type			Storm Grate/Utility Type	
		N/A			N/A
			Yes	Surface Condition? (G/P)	Good

Possible Solutions:

**Remove & Replace Entire Ramp.**

Total Cost: \$ 1850.00
