# Access Compliance Report

## Public Rights-of-Way

### (Curb Ramps)

Intersection ID: 11933	Main Street: N_TRYON_ST	Cross Street: E_8TH_ST	Location: N
ADA ID: B992ADFEA14F	Ramp Type: PerpDiag	Initial Pass/Fail: Fail	Overall Compliance: No
Severity Score: 12.5			
Codes/Mitigation Info/Possible Solution		Field Measurements/Component Compliance

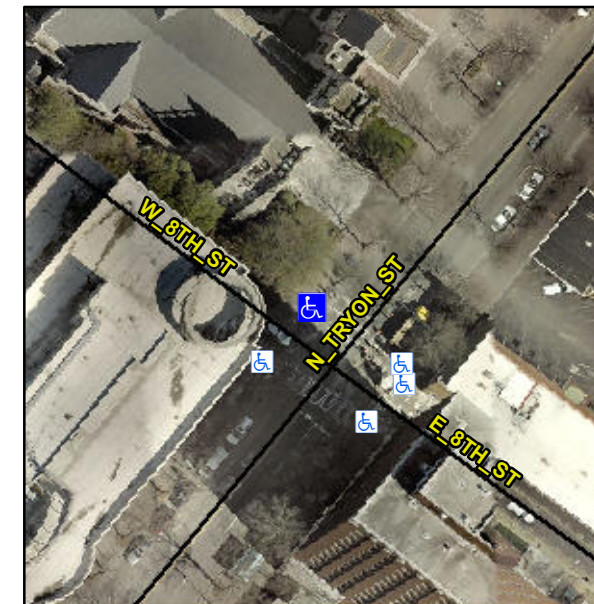
Compliance	Description	Data	Compliance	Description	Data
N/A	Ramp Length (in)	87.0	No	Ramp Slope (%)	9.5
Yes	Ramp Width (in)	48.0	Yes	Ramp XSlope (%)	2.0
N/A	Flare Type LT	N/A	N/A	Flare Type RT	N/A
N/A	Flare Slope LT (%)	N/A	N/A	Flare Slope RT (%)	N/A
N/A	Flare Traversable LT?	N/A	N/A	Flare Traversable RT?	N/A
N/A	Landing Length (in)	N/A	N/A	DWS Provided?	N/A
N/A	Landing Width (in)	N/A	N/A	DWS Contrast?	N/A
N/A	Landing Slope (%)	N/A	N/A	DWS Length (in)	N/A
N/A	Landing X Slope (%)	N/A	N/A	DWS Full Width?	N/A
N/A	Landing Curb? (Y/N)	N/A	N/A	DWS Offset (in)	N/A
N/A	Shared Landing?	N/A			
N/A	Gutter Ponding?	N/A	N/A	Gutter Slope (%)	N/A
N/A	Gutter Lip Ht (in)	N/A	N/A	Gutter X Slope (%)	N/A
N/A	Painted X Walk1?	Yes	N/A	Painted X Walk2?	Yes
	X Walk 1 Direction	To SW		X Walk 2 Direction	To SE
N/A	X Walk 1 Width (in)	108.0	N/A	X Walk 2 Width (in)	105.0
	X Walk 1 Slope (%)	3.7		X Walk 2 Slope (%)	3.7
	X Walk 1 X Slope (%)	0.0		X Walk 2 X Slope (%)	5.1

N/A	Ramp inside XWalk1?	Yes	N/A	Ramp inside XWalk2?	Yes
	Road Slope (%)	1.8	N/A	Clear Space?	N/A
	Road X Slope (%)	6.9	N/A	Clear Space to XWalk (in)	N/A
N/A	Any Obstructions?	N/A	N/A	Storm Grate/Utility Hazard?	N/A
	Obstruction Type			Storm Grate/Utility Type	
		N/A			N/A
		Yes		Surface Condition? (G/P)	Good

Possible Solutions:

**Remove & Replace Curb Ramp With Two New Directional Ramps or Equivalent.**

**R304.2.2**
