Access Compliance Report

Public Rights-of-Way

(Curb Ramps)

Intersection ID: N/A	Main Street: REA_RD	Cross Street: N/A	Location: NW
ADA ID: B9C0979C0A7D	Ramp Type: PerpDiag	Initial Pass/Fail: Fail	Overall Compliance: No
		Severity Score: 30

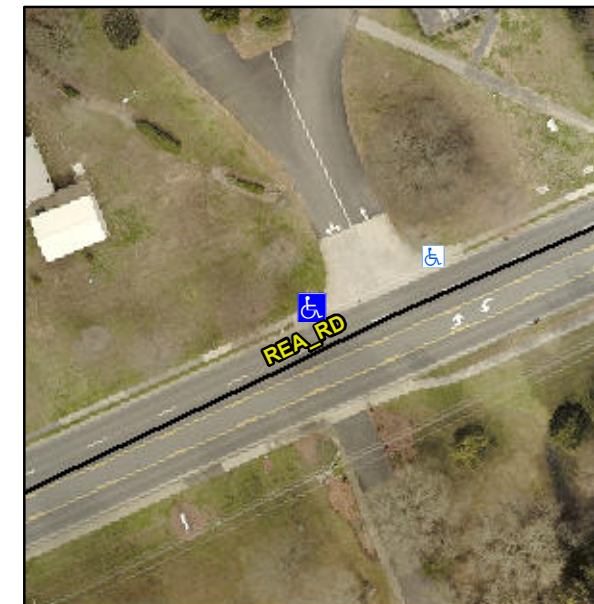
Not Found, R304.5.1, R304.2.2

Compliance	Description	Data	Compliance	Description	Data
N/A	Ramp Length (in)	71.0	No	Ramp Slope (%)	11.5
No	Ramp Width (in)	35.0	Yes	Ramp XSlope (%)	1.0
N/A	Flare Type LT	N/A	N/A	Flare Type RT	N/A
N/A	Flare Slope LT (%)	N/A	N/A	Flare Slope RT (%)	N/A
N/A	Flare Traversable LT?	N/A	N/A	Flare Traversable RT?	N/A
N/A	Landing Length (in)	N/A	N/A	DWS Provided?	N/A
N/A	Landing Width (in)	N/A	N/A	DWS Contrast?	N/A
N/A	Landing Slope (%)	N/A	N/A	DWS Length (in)	N/A
N/A	Landing X Slope (%)	N/A	N/A	DWS Full Width?	N/A
N/A	Landing Curb? (Y/N)	N/A	N/A	DWS Offset (in)	N/A
N/A	Shared Landing?	N/A			
N/A	Gutter Ponding?	N/A	N/A	Gutter Slope (%)	N/A
N/A	Gutter Lip Ht (in)	N/A	N/A	Gutter X Slope (%)	N/A
N/A	Painted X Walk1?	No	N/A	Painted X Walk2?	No
	X Walk 1 Direction	To S		X Walk 2 Direction	To E
N/A	X Walk 1 Width (in)	N/A	N/A	X Walk 2 Width (in)	N/A
	X Walk 1 Slope (%)	5.8		X Walk 2 Slope (%)	2.2
	X Walk 1 X Slope (%)	0.9		X Walk 2 X Slope (%)	3.6

N/A	Ramp inside XWalk1?	N/A	N/A	Ramp inside XWalk2?	N/A
	Road Slope (%)	0.1	N/A	Clear Space?	N/A
	Road X Slope (%)	3.8	N/A	Clear Space to XWalk (in)	N/A
N/A	Any Obstructions?	N/A	N/A	Storm Grate/Utility Hazard?	N/A
	Obstruction Type			Storm Grate/Utility Type	
		N/A			N/A
			Yes	Surface Condition? (G/P)	Good

Remove & Replace Curb Ramp With Two New Directional Ramps or Equivalent.
