Access Compliance Report

Public Rights-of-Way

(Curb Ramps)

Intersection ID: 14214	Main Street: E_PARK_AV	Cross Street: MYRTLE_AV	Location: SE
ADA ID: B9C74F3A4641	Ramp Type: PerpDiag	Initial Pass/Fail: Fail	Overall Compliance: No
Codes/Mitigation Info/Possible Solution			Severity Score: 35
			Field Measurements/Component Compliance

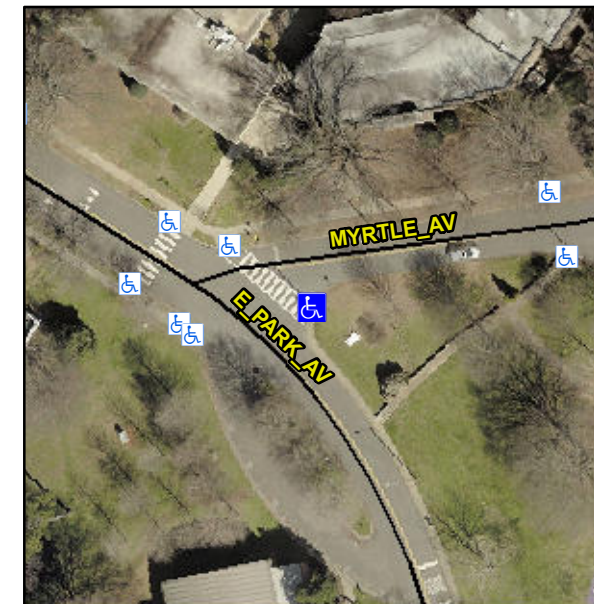
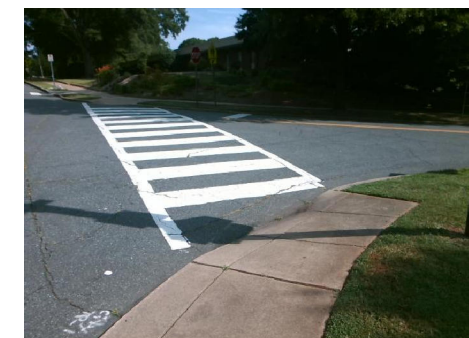
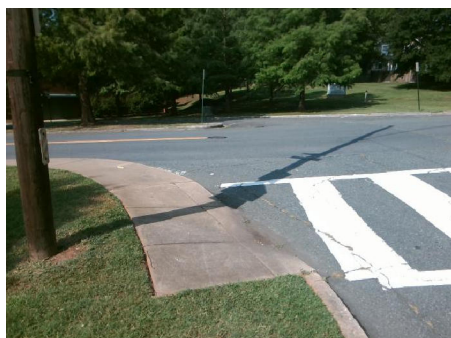
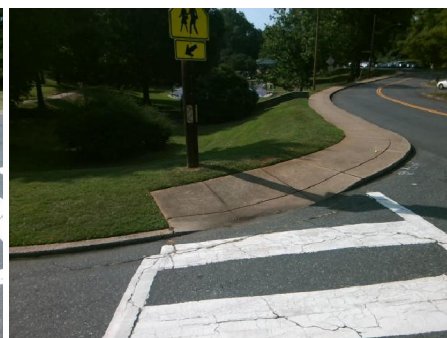
Not Found, R304.5.1, R304.2.2, R304.5.3

Compliance	Description	Data	Compliance	Description	Data
N/A	Ramp Length (in)	39.0	No	Ramp Slope (%)	12.8
No	Ramp Width (in)	46.0	No	Ramp XSlope (%)	4.3
N/A	Flare Type LT	N/A	N/A	Flare Type RT	N/A
N/A	Flare Slope LT (%)	N/A	N/A	Flare Slope RT (%)	N/A
N/A	Flare Traversable LT?	N/A	N/A	Flare Traversable RT?	N/A
N/A	Landing Length (in)	N/A	N/A	DWS Provided?	N/A
N/A	Landing Width (in)	N/A	N/A	DWS Contrast?	N/A
N/A	Landing Slope (%)	N/A	N/A	DWS Length (in)	N/A
N/A	Landing X Slope (%)	N/A	N/A	DWS Full Width?	N/A
N/A	Landing Curb? (Y/N)	N/A	N/A	DWS Offset (in)	N/A
N/A	Shared Landing?	N/A			
N/A	Gutter Ponding?	N/A	N/A	Gutter Slope (%)	N/A
N/A	Gutter Lip Ht (in)	N/A	N/A	Gutter X Slope (%)	N/A
N/A	Painted X Walk1?	Yes	N/A	Painted X Walk2?	No
	X Walk 1 Direction	To NW		X Walk 2 Direction	To W
N/A	X Walk 1 Width (in)	108.0	N/A	X Walk 2 Width (in)	N/A
	X Walk 1 Slope (%)	9.6		X Walk 2 Slope (%)	1.5
	X Walk 1 X Slope (%)	5.8		X Walk 2 X Slope (%)	6.0

N/A	Ramp inside XWalk1?	Yes	N/A	Ramp inside XWalk2?	N/A
	Road Slope (%)	0.4	N/A	Clear Space?	N/A
	Road X Slope (%)	12.4	N/A	Clear Space to XWalk (in)	N/A
N/A	Any Obstructions?	N/A	N/A	Storm Grate/Utility Hazard?	N/A
	Obstruction Type			Storm Grate/Utility Type	
		N/A			N/A
		Yes		Surface Condition? (G/P)	Good

Possible Solutions:

Remove & Replace Curb Ramp With Two New Directional Ramps or Equivalent.
