Access Compliance Report Public Rights-of-Way (Curb Ramps)

Intersection ID: 12158Main Street: W_MOREHEAD_STCross Street: SUTTLE_AVLocation:NWADA ID: B9CD8BF78B5FRamp Type: ParaInitial Pass/Fail: FailOverall Compliance: NoSeverity Score: 12.5

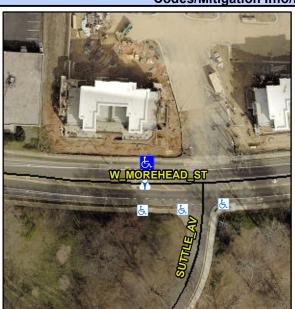
Field Measurements/Component Compliance							
Comp	liance Description	Data	Comp	liance Description	Data		
N/A	Ramp Length LT (in)	69.0	N/A	Ramp Length RT (in)	66.0		
Yes	Ramp Width LT (in)	59.0	Yes	Ramp Width RT (in)	60.5		
No	Ramp Slope LT (%)	9.3	Yes	Ramp Slope RT (%)	6.8		
Yes	Ramp XSlope LT (%)	0.6	Yes	Ramp XSlope RT (%)	1.0		
N/A	Landing Length (in)	N/A	N/A	DWS Provided?	N/A		
N/A	Landing Width (in)	N/A	N/A	DWS Contrast?	N/A		
N/A	Landing Slope (%)	N/A	N/A	DWS Length (in)	N/A		
N/A	Landing X Slope (%)	N/A	N/A	DWS Full Width?	N/A		
N/A	Landing Curb? (Y/N)	N/A	N/A	DWS Offset (in)	N/A		
N/A	Shared Landing?	N/A					
N/A	Gutter Ponding?	N/A	N/A	Gutter Slope (%)	N/A		
N/A	Gutter Lip Ht (in)	N/A	N/A	Gutter X Slope (%)	N/A		
N/A	Painted X Walk1?	No	N/A	Painted X Walk2?	N/A		
	X Walk 1 Direction	To S		X Walk 2 Direction	N/A		
N/A	X Walk 1 Width (in)	N/A	N/A	X Walk 2 Width (in)	N/A		
	X Walk 1 Slope (%)	6.1		X Walk 2 Slope (%)	N/A

X Walk 1 X Slope (%)	7.6		X Walk 2 X Slope (%)	N/A		
N/A	Ramp inside XWalk1?	N/A	N/A	Ramp inside XWalk2?	N/A		
	Road Slope (%)	N/A	N/A	Clear Space?	N/A		
	Road X Slope (%)	N/A	N/A	Clear Space to XWalk (in)	N/A		
N/A	Any Obstructions?	N/A	N/A	Storm Grate/Utility Hazard?	N/A		
	Obstruction Type			Storm Grate/Utility Type			
		N/A			N/A		
			Yes	Surface Condition? (G/P)	Good		
			N/A	Curb Slope (%)	5.4

Possible Solution		
Possible Solutions:	9	
Remove & Replace Entire Ramp.		
·	١	
	1	
	١	
	N	
	N	
Surveyor Notes:	N	
N/A	N	
	N	
	N	
	N	
PROW/ADA:	N	
R304.3.2	N	
	N

Total Cost: \$ 1600.00
