Access Compliance Report

Public Rights-of-Way

(Curb Ramps)

Intersection ID: 18602	Main Street: JESTER_LN	Cross Street: RAMA_RD	Location: S
ADA ID: B9D045CFCBD1	Ramp Type: PerpDiag	Initial Pass/Fail: Fail	Overall Compliance: No
		Severity Score: 12.5

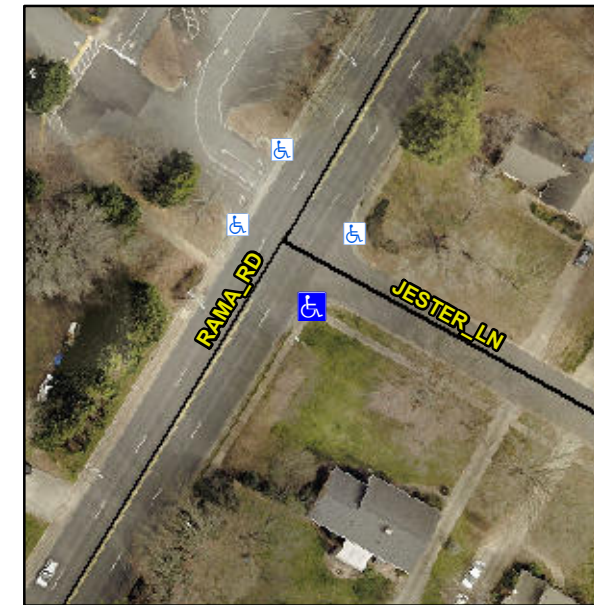
Not Found, R304.5.3

Compliance	Description	Data	Compliance	Description	Data
N/A	Ramp Length (in)	81.0	Yes	Ramp Slope (%)	6.6
Yes	Ramp Width (in)	50.0	No	Ramp XSlope (%)	5.5
N/A	Flare Type LT	N/A	N/A	Flare Type RT	N/A
N/A	Flare Slope LT (%)	N/A	N/A	Flare Slope RT (%)	N/A
N/A	Flare Traversable LT?	N/A	N/A	Flare Traversable RT?	N/A
N/A	Landing Length (in)	N/A	N/A	DWS Provided?	N/A
N/A	Landing Width (in)	N/A	N/A	DWS Contrast?	N/A
N/A	Landing Slope (%)	N/A	N/A	DWS Length (in)	N/A
N/A	Landing X Slope (%)	N/A	N/A	DWS Full Width?	N/A
N/A	Landing Curb? (Y/N)	N/A	N/A	DWS Offset (in)	N/A
N/A	Shared Landing?	N/A			
N/A	Gutter Ponding?	N/A	N/A	Gutter Slope (%)	N/A
N/A	Gutter Lip Ht (in)	N/A	N/A	Gutter X Slope (%)	N/A
N/A	Painted X Walk1?	No	N/A	Painted X Walk2?	No
	X Walk 1 Direction	To NE		X Walk 2 Direction	To NW
N/A	X Walk 1 Width (in)	N/A	N/A	X Walk 2 Width (in)	N/A
	X Walk 1 Slope (%)	2.2		X Walk 2 Slope (%)	8.2
	X Walk 1 X Slope (%)	4.2		X Walk 2 X Slope (%)	2.3

N/A	Ramp inside XWalk1?	N/A	N/A	Ramp inside XWalk2?	N/A
	Road Slope (%)	3.0	N/A	Clear Space?	N/A
	Road X Slope (%)	7.8	N/A	Clear Space to XWalk (in)	N/A
N/A	Any Obstructions?	N/A	N/A	Storm Grate/Utility Hazard?	N/A
	Obstruction Type			Storm Grate/Utility Type	
		N/A			N/A
			Yes	Surface Condition? (G/P)	Good

Possible Solutions:

Remove & Replace Curb Ramp With Two New Directional Ramps or Equivalent.
