# Access Compliance Report

## Public Rights-of-Way

### (Curb Ramps)

Intersection ID: 9059	Main Street: GLENWOOD_DR	Cross Street: S_I-85_EXIT_35_RA	Location: NE
ADA ID: B9D3D9C006CF	Ramp Type: Perp	Initial Pass/Fail: Fail	Overall Compliance: No
Severity Score: 21.25			
Codes/Mitigation Info/Possible Solution		Field Measurements/Component Compliance

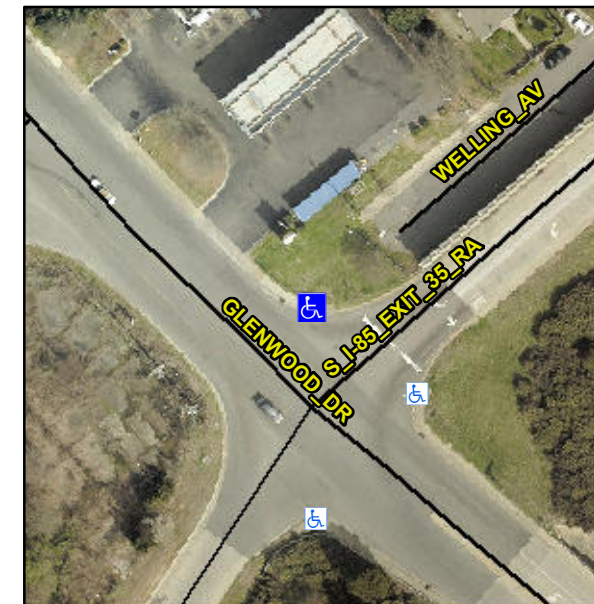
**Not Found, R304.5.1, R304.2.2**

Compliance	Description	Data	Compliance	Description	Data
N/A	Ramp Length (in)	48.0	No	Ramp Slope (%)	10.3
No	Ramp Width (in)	40.0	Yes	Ramp XSlope (%)	1.3
N/A	Flare Type LT	N/A	N/A	Flare Type RT	N/A
N/A	Flare Slope LT (%)	N/A	N/A	Flare Slope RT (%)	N/A
N/A	Flare Traversable LT?	N/A	N/A	Flare Traversable RT?	N/A
N/A	Landing Length (in)	N/A	N/A	DWS Provided?	N/A
N/A	Landing Width (in)	N/A	N/A	DWS Contrast?	N/A
N/A	Landing Slope (%)	N/A	N/A	DWS Length (in)	N/A
N/A	Landing X Slope (%)	N/A	N/A	DWS Full Width?	N/A
N/A	Landing Curb? (Y/N)	N/A	N/A	DWS Offset (in)	N/A
N/A	Shared Landing?	N/A			
N/A	Gutter Ponding?	N/A	N/A	Gutter Slope (%)	N/A
N/A	Gutter Lip Ht (in)	N/A	N/A	Gutter X Slope (%)	N/A
N/A	Painted X Walk1?	No	N/A	Painted X Walk2?	N/A
	X Walk 1 Direction	To N		X Walk 2 Direction	N/A
N/A	X Walk 1 Width (in)	N/A	N/A	X Walk 2 Width (in)	N/A
	X Walk 1 Slope (%)	1.5		X Walk 2 Slope (%)	N/A
	X Walk 1 X Slope (%)	4.9		X Walk 2 X Slope (%)	N/A

N/A	Ramp inside XWalk1?	N/A	N/A	Ramp inside XWalk2?	N/A
	Road Slope (%)	N/A	N/A	Clear Space?	N/A
	Road X Slope (%)	N/A	N/A	Clear Space to XWalk (in)	N/A
N/A	Any Obstructions?	N/A	N/A	Storm Grate/Utility Hazard?	N/A
	Obstruction Type			Storm Grate/Utility Type	
		N/A			N/A
			Yes	Surface Condition? (G/P)	Good

**Remove & Replace Entire Ramp.**

Total Cost: \$ 1850.00
