# Access Compliance Report

## Public Rights-of-Way

### (Curb Ramps)

Intersection ID: 20221	Main Street: BARCLAY_DOWNS_DR	Cross Street: FAIRVIEW_RD	Location: SE
ADA ID: B9D6DEB8336C	Ramp Type: PerpDiag	Initial Pass/Fail: Fail	Overall Compliance: No
Severity Score: 21.25			
Codes/Mitigation Info/Possible Solution		Field Measurements/Component Compliance

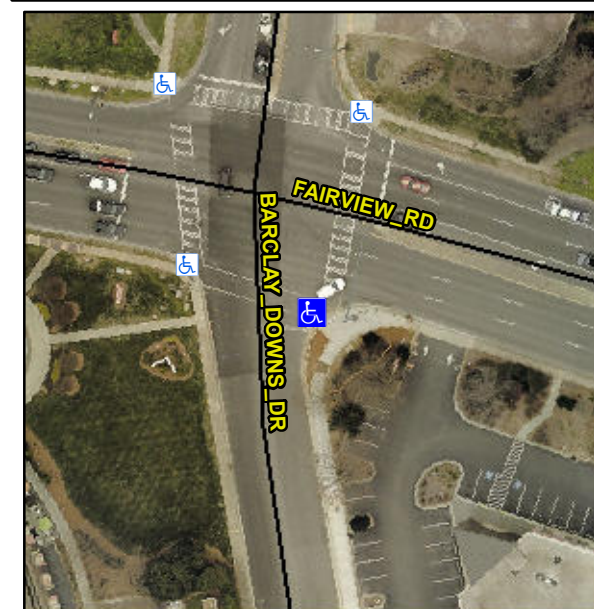
**Not Found, R304.5.1, R304.5.3**

Compliance	Description	Data	Compliance	Description	Data
N/A	Ramp Length (in)	62.0	Yes	Ramp Slope (%)	5.5
No	Ramp Width (in)	44.0	No	Ramp XSlope (%)	5.2
N/A	Flare Type LT	N/A	N/A	Flare Type RT	N/A
N/A	Flare Slope LT (%)	N/A	N/A	Flare Slope RT (%)	N/A
N/A	Flare Traversable LT?	N/A	N/A	Flare Traversable RT?	N/A
N/A	Landing Length (in)	N/A	N/A	DWS Provided?	N/A
N/A	Landing Width (in)	N/A	N/A	DWS Contrast?	N/A
N/A	Landing Slope (%)	N/A	N/A	DWS Length (in)	N/A
N/A	Landing X Slope (%)	N/A	N/A	DWS Full Width?	N/A
N/A	Landing Curb? (Y/N)	N/A	N/A	DWS Offset (in)	N/A
N/A	Shared Landing?	N/A			
N/A	Gutter Ponding?	N/A	N/A	Gutter Slope (%)	N/A
N/A	Gutter Lip Ht (in)	N/A	N/A	Gutter X Slope (%)	N/A
N/A	Painted X Walk1?	Yes	N/A	Painted X Walk2?	Yes
	X Walk 1 Direction	To NE		X Walk 2 Direction	To NW
N/A	X Walk 1 Width (in)	106.0	N/A	X Walk 2 Width (in)	110.0
	X Walk 1 Slope (%)	5.3		X Walk 2 Slope (%)	2.6
	X Walk 1 X Slope (%)	2.6		X Walk 2 X Slope (%)	5.2

N/A	Ramp inside XWalk1?	Yes	N/A	Ramp inside XWalk2?	Yes
	Road Slope (%)	0.6	N/A	Clear Space?	N/A
	Road X Slope (%)	4.3	N/A	Clear Space to XWalk (in)	N/A
N/A	Any Obstructions?	N/A	N/A	Storm Grate/Utility Hazard?	N/A
	Obstruction Type			Storm Grate/Utility Type	
		N/A			N/A
		Yes		Surface Condition? (G/P)	Good

**Remove & Replace Curb Ramp With Two New Directional Ramps or Equivalent.**
