# Access Compliance Report

## Public Rights-of-Way

### (Curb Ramps)

Intersection ID: 2758	Main Street: BUCKSPRING_LN	Cross Street: SKYLINE_DR	Location: NW
ADA ID: B9D7F863C4E6	Ramp Type: PerpDiag	Initial Pass/Fail: Fail	Overall Compliance: No
Severity Score: 21.25			
Codes/Mitigation Info/Possible Solution		Field Measurements/Component Compliance

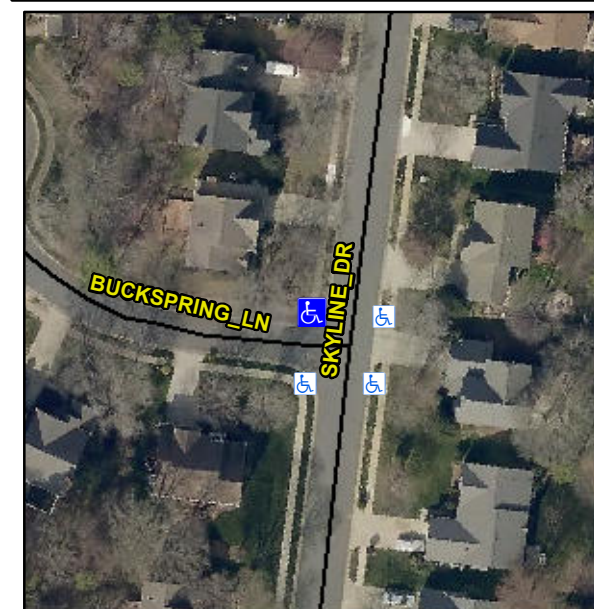
**R304.5.1, R304.5.3**

Compliance	Description	Data	Compliance	Description	Data
N/A	Ramp Length (in)	51.0	Yes	Ramp Slope (%)	7.9
No	Ramp Width (in)	38.0	No	Ramp XSlope (%)	5.3
N/A	Flare Type LT	N/A	N/A	Flare Type RT	N/A
N/A	Flare Slope LT (%)	N/A	N/A	Flare Slope RT (%)	N/A
N/A	Flare Traversable LT?	N/A	N/A	Flare Traversable RT?	N/A
N/A	Landing Length (in)	N/A	N/A	DWS Provided?	N/A
N/A	Landing Width (in)	N/A	N/A	DWS Contrast?	N/A
N/A	Landing Slope (%)	N/A	N/A	DWS Length (in)	N/A
N/A	Landing X Slope (%)	N/A	N/A	DWS Full Width?	N/A
N/A	Landing Curb? (Y/N)	N/A	N/A	DWS Offset (in)	N/A
N/A	Shared Landing?	N/A			
N/A	Gutter Ponding?	N/A	N/A	Gutter Slope (%)	N/A
N/A	Gutter Lip Ht (in)	N/A	N/A	Gutter X Slope (%)	N/A
N/A	Painted X Walk1?	No	N/A	Painted X Walk2?	No
	X Walk 1 Direction	To S		X Walk 2 Direction	To E
N/A	X Walk 1 Width (in)	N/A	N/A	X Walk 2 Width (in)	N/A
	X Walk 1 Slope (%)	2.8		X Walk 2 Slope (%)	3.1
	X Walk 1 X Slope (%)	3.4		X Walk 2 X Slope (%)	4.2

N/A	Ramp inside XWalk1?	N/A	N/A	Ramp inside XWalk2?	N/A
	Road Slope (%)	5.2	N/A	Clear Space?	N/A
	Road X Slope (%)	1.2	N/A	Clear Space to XWalk (in)	N/A
N/A	Any Obstructions?	N/A	N/A	Storm Grate/Utility Hazard?	N/A
	Obstruction Type			Storm Grate/Utility Type	
		N/A			N/A
		Yes		Surface Condition? (G/P)	Good

**Remove & Replace Curb Ramp With Two New Directional Ramps or Equivalent.**

Total Cost: \$ 3200.00
