Access Compliance Report

Public Rights-of-Way

(Curb Ramps)

Intersection ID: 10617	Main Street: STATE_ST	Cross Street: WHITEHAVEN_AV	Location: SW
ADA ID: B9D9A233FD2D	Ramp Type: PerpDiag	Initial Pass/Fail: Fail	Overall Compliance: No
		Severity Score: 10

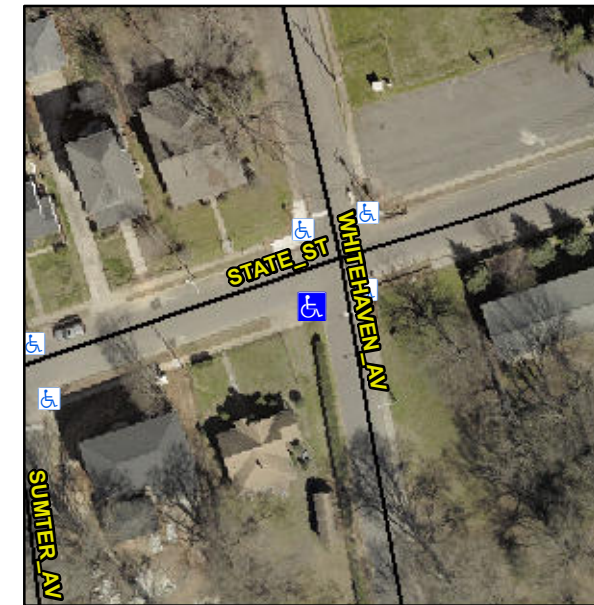
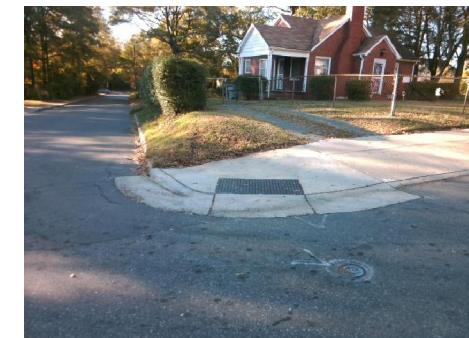
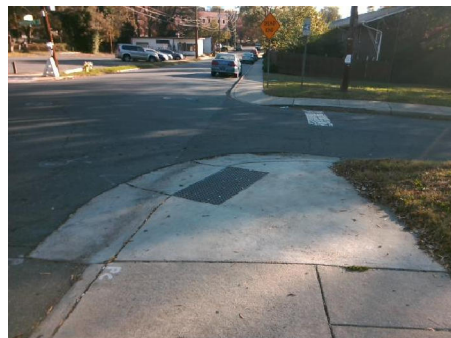
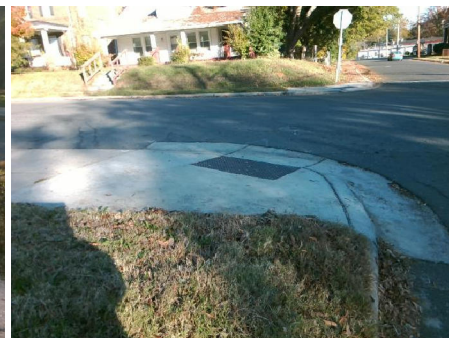
Not Found, R304.5.1, R304.5.3

Compliance	Description	Data	Compliance	Description	Data
N/A	Ramp Length (in)	48.0	Yes	Ramp Slope (%)	6.2
No	Ramp Width (in)	47.5	No	Ramp XSlope (%)	3.5
N/A	Flare Type LT	N/A	N/A	Flare Type RT	N/A
N/A	Flare Slope LT (%)	N/A	N/A	Flare Slope RT (%)	N/A
N/A	Flare Traversable LT?	N/A	N/A	Flare Traversable RT?	N/A
N/A	Landing Length (in)	N/A	N/A	DWS Provided?	N/A
N/A	Landing Width (in)	N/A	N/A	DWS Contrast?	N/A
N/A	Landing Slope (%)	N/A	N/A	DWS Length (in)	N/A
N/A	Landing X Slope (%)	N/A	N/A	DWS Full Width?	N/A
N/A	Landing Curb? (Y/N)	N/A	N/A	DWS Offset (in)	N/A
N/A	Shared Landing?	N/A			
N/A	Gutter Ponding?	N/A	N/A	Gutter Slope (%)	N/A
N/A	Gutter Lip Ht (in)	N/A	N/A	Gutter X Slope (%)	N/A
N/A	Painted X Walk1?	No	N/A	Painted X Walk2?	No
	X Walk 1 Direction	To E		X Walk 2 Direction	To N
N/A	X Walk 1 Width (in)	N/A	N/A	X Walk 2 Width (in)	N/A
	X Walk 1 Slope (%)	1.8		X Walk 2 Slope (%)	4.2
	X Walk 1 X Slope (%)	5.2		X Walk 2 X Slope (%)	4.3

N/A	Ramp inside XWalk1?	N/A	N/A	Ramp inside XWalk2?	N/A
	Road Slope (%)	6.1	N/A	Clear Space?	N/A
	Road X Slope (%)	1.6	N/A	Clear Space to XWalk (in)	N/A
N/A	Any Obstructions?	N/A	N/A	Storm Grate/Utility Hazard?	N/A
	Obstruction Type			Storm Grate/Utility Type	
		N/A			N/A
			Yes	Surface Condition? (G/P)	Good

Remove & Replace Curb Ramp With Two New Directional Ramps or Equivalent.
