Access Compliance Report

Public Rights-of-Way

(Curb Ramps)

Intersection ID: 5563	Main Street: N I-77 EXIT 16 RA	Cross Street: N/A	Location: NE
ADA ID: B9DF8AD0B6A9	Ramp Type: BlendTrans2	Initial Pass/Fail: Fail	Overall Compliance: No
Severity Score: 21.25			
Codes/Mitigation Info/Possible Solution		Field Measurements/Component Compliance

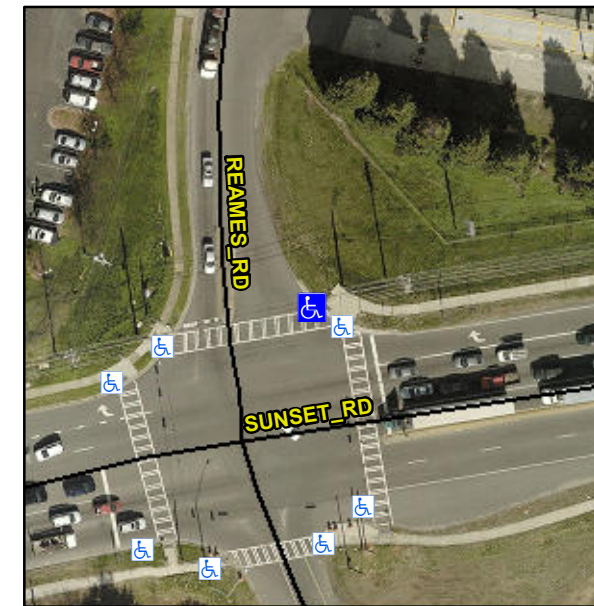
Compliance	Description	Data	Compliance	Description	Data
N/A	Ramp Length (in)	91.5	Yes	BlendTrans Slope (%)	4.7
No	Ramp Width (in)	44.0	No	BlendTrans XSlope (%)	5.7
N/A	Flare Type LT	N/A	N/A	Flare Type RT	N/A
N/A	Flare Slope LT (%)	N/A	N/A	Flare Slope RT (%)	N/A
N/A	Flare Traversable LT?	N/A	N/A	Flare Traversable RT?	N/A
N/A	Landing Length (in)	N/A	N/A	DWS Provided?	N/A
N/A	Landing Width (in)	N/A	N/A	DWS Contrast?	N/A
N/A	Landing Slope (%)	N/A	N/A	DWS Length (in)	N/A
N/A	Landing X Slope (%)	N/A	N/A	DWS Full Width?	N/A
N/A	Landing Curb? (Y/N)	N/A	N/A	DWS Offset (in)	N/A
N/A	Shared Landing?	N/A			
N/A	Gutter Ponding?	N/A	N/A	Gutter Slope (%)	N/A
N/A	Gutter Lip Ht (in)	N/A	N/A	Gutter X Slope (%)	N/A
N/A	Painted X Walk1?	Yes	N/A	Painted X Walk2?	N/A
	X Walk 1 Direction	To W		X Walk 2 Direction	N/A
	X Walk 1 Width (in)	112.0		X Walk 2 Width (in)	N/A
	X Walk 1 Slope (%)	4.4		X Walk 2 Slope (%)	N/A
	X Walk 1 X Slope (%)	2.6		X Walk 2 X Slope (%)	N/A

N/A	Ramp inside XWalk1?	Yes	N/A	Ramp inside XWalk2?	N/A
	Road Slope (%)	2.6		Clear Space?	N/A
	Road X Slope (%)	4.4	N/A	Clear Space to XWalk (in)	N/A
N/A	Any Obstructions?	N/A	N/A	Storm Grate/Utility Hazard?	N/A
	Obstruction Type			Storm Grate/Utility Type	
		N/A			N/A
			Yes	Surface Condition? (G/P)	Good
			N/A	Curb Slope (%)	4.8

Possible Solutions:

Remove & Replace Curb Ramp With Two New Directional Ramps or Equivalent.

R304.5.1, R304.5.3
