Access Compliance Report

Public Rights-of-Way

(Curb Ramps)

Intersection ID: 2457	Main Street: CAMBELLTON_DR	Cross Street: CLARKE_CREEK_PY	Location: SE
ADA ID: B9F9D555749E	Ramp Type: PerpDiag	Initial Pass/Fail: Fail	Overall Compliance: No
Severity Score: 33.75			
Codes/Mitigation Info/Possible Solution		Field Measurements/Component Compliance

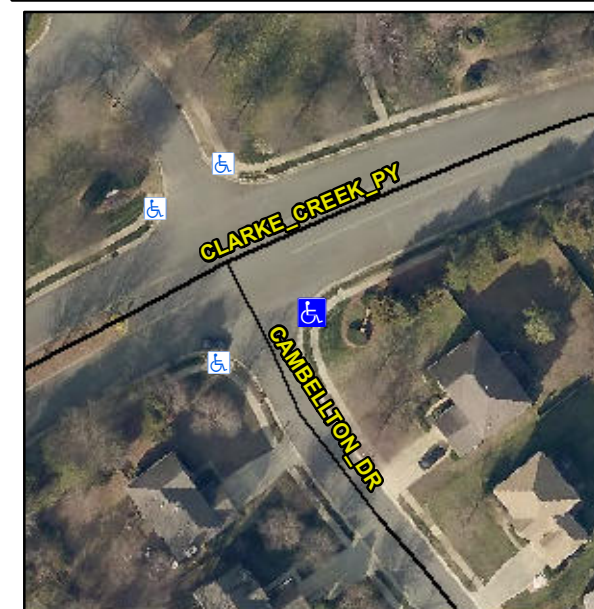
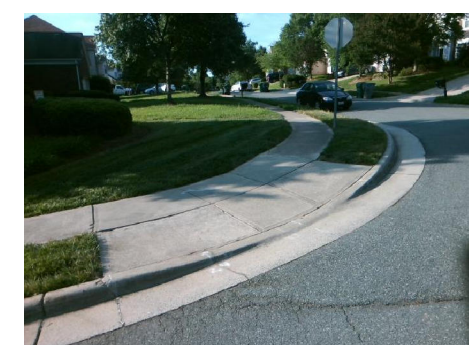
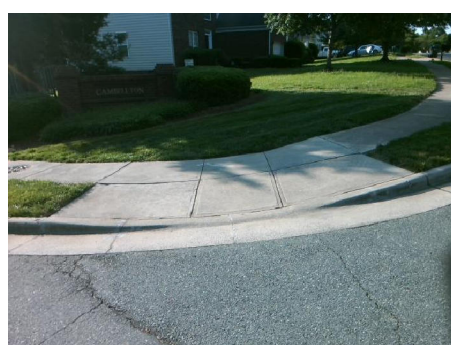
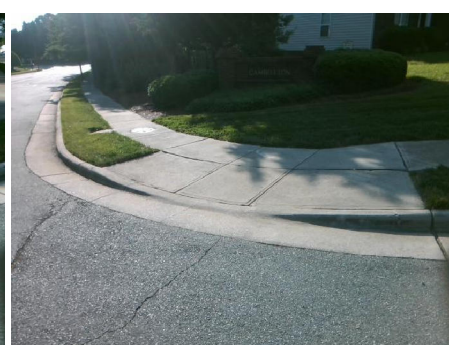
Compliance	Description	Data	Compliance	Description	Data
N/A	Ramp Length (in)	49.0	No	Ramp Slope (%)	8.4
No	Ramp Width (in)	45.5	No	Ramp XSlope (%)	6.5
N/A	Flare Type LT	N/A	N/A	Flare Type RT	N/A
N/A	Flare Slope LT (%)	N/A	N/A	Flare Slope RT (%)	N/A
N/A	Flare Traversable LT?	N/A	N/A	Flare Traversable RT?	N/A
N/A	Landing Length (in)	N/A	N/A	DWS Provided?	N/A
N/A	Landing Width (in)	N/A	N/A	DWS Contrast?	N/A
N/A	Landing Slope (%)	N/A	N/A	DWS Length (in)	N/A
N/A	Landing X Slope (%)	N/A	N/A	DWS Full Width?	N/A
N/A	Landing Curb? (Y/N)	N/A	N/A	DWS Offset (in)	N/A
N/A	Shared Landing?	N/A			
N/A	Gutter Ponding?	N/A	N/A	Gutter Slope (%)	N/A
N/A	Gutter Lip Ht (in)	N/A	N/A	Gutter X Slope (%)	N/A
N/A	Painted X Walk1?	No	N/A	Painted X Walk2?	No
	X Walk 1 Direction	To N		X Walk 2 Direction	To W
N/A	X Walk 1 Width (in)	N/A	N/A	X Walk 2 Width (in)	N/A
	X Walk 1 Slope (%)	0.7		X Walk 2 Slope (%)	6.5
	X Walk 1 X Slope (%)	6.9		X Walk 2 X Slope (%)	0.4

N/A	Ramp inside XWalk1?	N/A	N/A	Ramp inside XWalk2?	N/A
	Road Slope (%)	4.2	N/A	Clear Space?	N/A
	Road X Slope (%)	5.0	N/A	Clear Space to XWalk (in)	N/A
N/A	Any Obstructions?	N/A	N/A	Storm Grate/Utility Hazard?	N/A
	Obstruction Type			Storm Grate/Utility Type	
		N/A			N/A
			Yes	Surface Condition? (G/P)	Good

Possible Solutions:

Remove & Replace Curb Ramp With Two New Directional Ramps or Equivalent.

R304.5.1, R304.2.2, R304.5.3
