# Access Compliance Report

## Public Rights-of-Way

### (Curb Ramps)

| Intersection ID: N/A | Main Street: ARBOR_LOOP_DR | Cross Street: POTOMAC_RIVER_PY | Location: W |

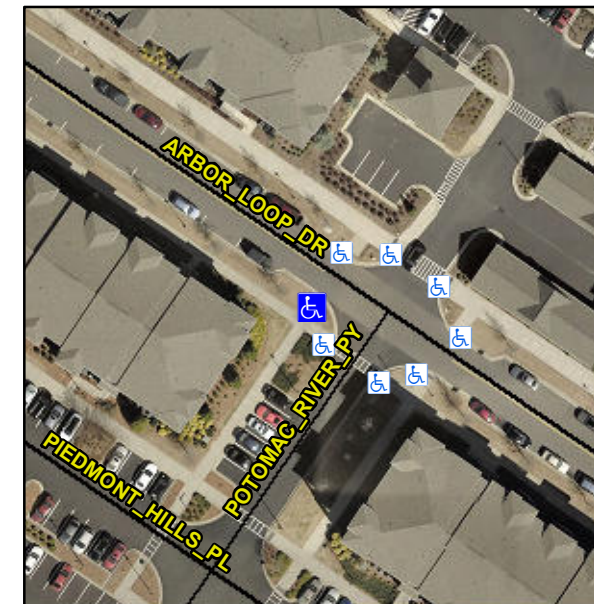
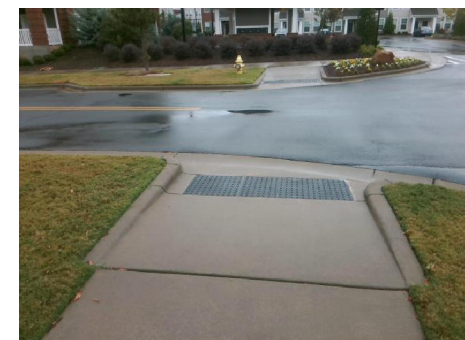
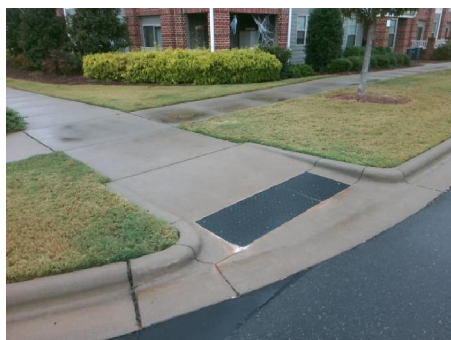
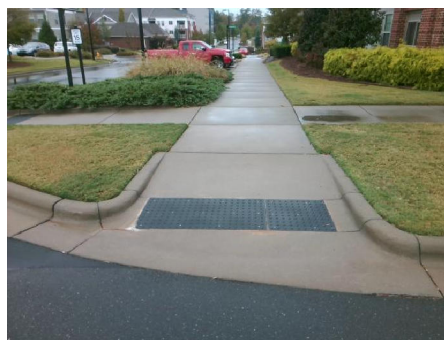
| ADA ID: B9FC7B321CFB | Ramp Type: BlendTrans1 | Initial Pass/Fail: Pass | Overall Compliance: No |
| | | Severity Score: 7.5 | |

| Compliance | Description | Data | Compliance | Description | Data |
|---|---|---|---|---|---|
| No | Landing Slope (%) | 3.2 | Yes | DWS Length (in) | 24.0 |
| Yes | Landing X Slope (%) | 1.1 | No | DWS Full Width? | No |
| Yes | Gutter Ponding? | No | No | Gutter Slope (%) | 7.7 |
| Yes | Gutter Lip Ht (in) | 0.0 | No | Gutter X Slope (%) | 2.5 |

**Remove & Replace Curb Ramp With Two New Directional Ramps or Equivalent. Remove & Replace Gutter.**

**R304.2.2-Perp, R304.3.2-Para, R305.1.4, R304.5.4, R304.5.3**
