# Access Compliance Report

## Public Rights-of-Way

| Intersection ID: 49292 | Main Street: ROYAL_WINCHESTER_DR | Cross Street: CHAMBERLIN_RD | Location: NW |
| ADA ID: BA06339C2BA9 | Ramp Type: PerpDiag | Initial Pass/Fail: Pass | Overall Compliance: No |

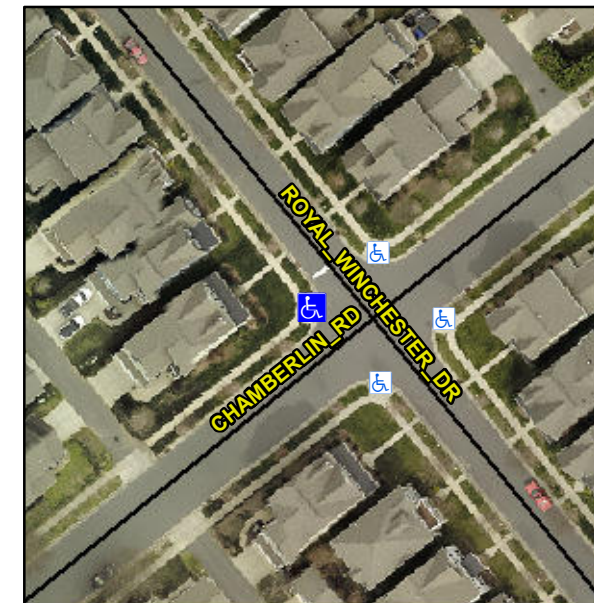
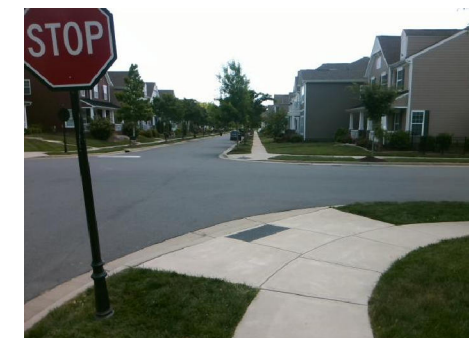
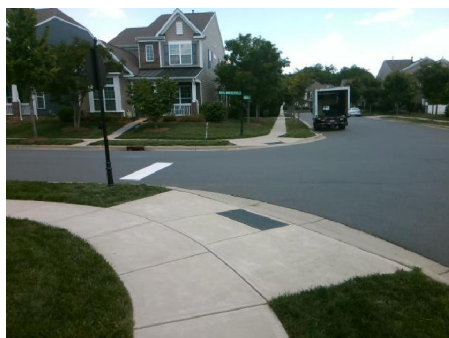
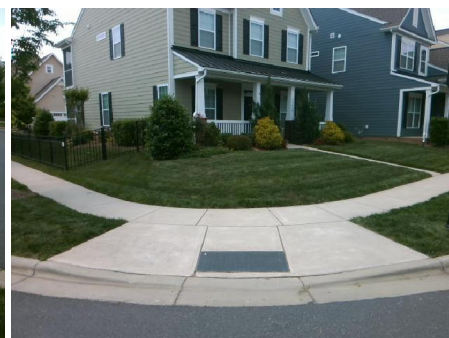
| Severity Score: 7.5 | | | |

**R304.2.1, R304.2.2-Perp, R304.3.2-Para, R304.5.3, R305.2, R302.7.2**

| Compliance | Description | Data | Compliance | Description | Data |
|---|---|---|---|---|---|
| No | Landing Length (in) | 46.5 | Yes | DWS Provided? | Yes |
| No | Landing Slope (%) | 2.8 | Yes | DWS Length (in) | 24.0 |
| No | Landing X Slope (%) | 3.0 | Yes | DWS Full Width? | Yes |
| N/A | Landing Curb? (Y/N) | No | No | DWS Offset (in) | 5.0 |
| No | Gutter Lip Ht (in) | 0.5 | Yes | Gutter X Slope (%) | 0.7 |

**Remove & Replace Curb Ramp With Two New Directional Ramps or Equivalent. Grind Gutter Lip.**

Total Cost: \$ 3400.00
