Intersection ID: 54616	Main Street: RUMPLE_RD	Cross Street: UNIVERSITY_CITY_BV	Location:	NE
ADA ID: BA0882CF3A41	Ramp Type: PerpDiag	Initial Pass/Fail: Fail	Overall Compliance: No	Severity Score: 8.75

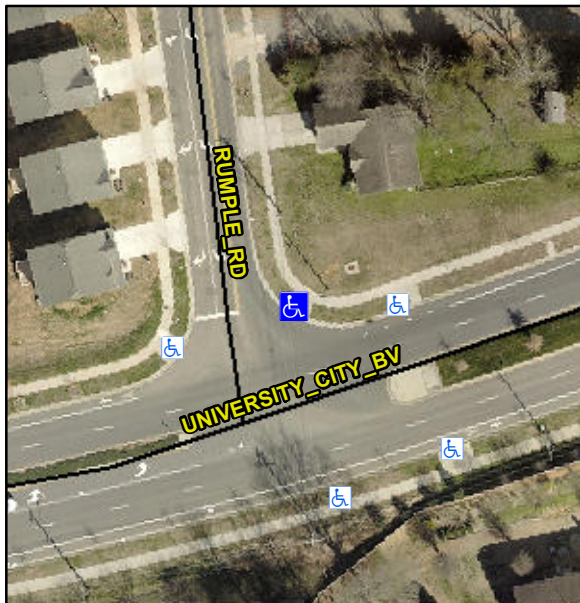
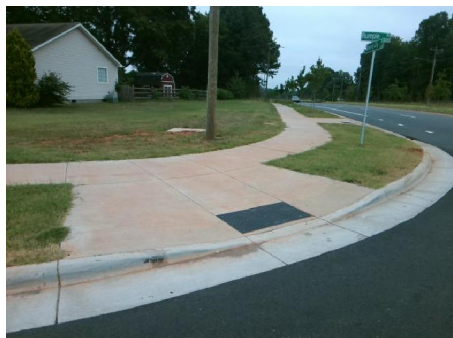
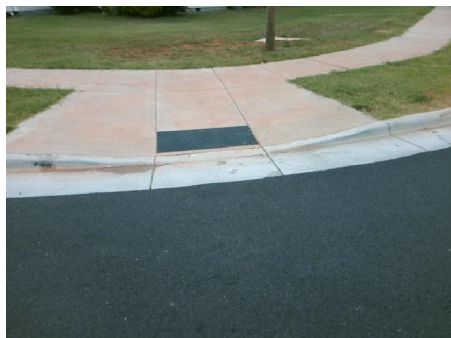
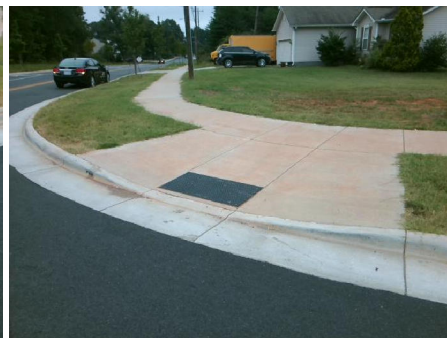
Possible Solutions:			Compliance	Description	Data	Compliance	Description	Data
	Remove & Replace Curb Ramp With Two New Directional Ramps or Equivalent.			N/A	Ramp Length (in)	96.0	Yes	Ramp Slope (%)	5.4
				No	Ramp Width (in)	47.5	Yes	Ramp XSlope (%)	0.5
				N/A	Flare Type LT	N/A	N/A	Flare Type RT	N/A
				N/A	Flare Slope LT (%)	N/A	N/A	Flare Slope RT (%)	N/A
				N/A	Flare Traversable LT?	N/A	N/A	Flare Traversable RT?	N/A
	Surveyor Notes:			N/A	Landing Length (in)	N/A	N/A	DWS Provided?	N/A
				N/A	Landing Width (in)	N/A	N/A	DWS Contrast?	N/A
				N/A	Landing Slope (%)	N/A	N/A	DWS Length (in)	N/A
				N/A	Landing X Slope (%)	N/A	N/A	DWS Full Width?	N/A
N/A				Landing Curb? (Y/N)	N/A	N/A	DWS Offset (in)	N/A	
PROW/ADA:			N/A	Shared Landing?	N/A				
			N/A	Gutter Ponding?	N/A	N/A	Gutter Slope (%)	N/A	
			N/A	Gutter Lip Ht (in)	N/A	N/A	Gutter X Slope (%)	N/A

N/A	Painted X Walk1?	No	N/A	Painted X Walk2?	No	
				X Walk 1 Direction	To W		X Walk 2 Direction	To S	
Total Cost:			N/A	X Walk 1 Width (in)	N/A	N/A	X Walk 2 Width (in)	N/A	
				X Walk 1 Slope (%)	0.9		X Walk 2 Slope (%)	2.8	
				X Walk 1 X Slope (%)	2.0		X Walk 2 X Slope (%)	3.7	
			N/A	Ramp inside XWalk1?	N/A	N/A	Ramp inside XWalk2?	N/A	
				Road Slope (%)	0.2	N/A	Clear Space?	N/A	
				Road X Slope (%)	4.1	N/A	Clear Space to XWalk (in)	N/A	
			N/A	Any Obstructions?	N/A	N/A	Storm Grate/Utility Hazard?	N/A	
				Obstruction Type			Storm Grate/Utility Type		
					N/A			N/A	
						Yes	Surface Condition? (G/P)	Good
