## **Access Compliance Report Public Rights-of-Way** (Curb Ramps)

Intersection ID: 46489 Main Street: BALLYBAY\_DR Cross Street: TRAILMOOR\_RD Location: NW **Severity Score: Overall Compliance: No ADA ID: BA0990F598BA** Ramp Type: Perp Initial Pass/Fail: Fail 10

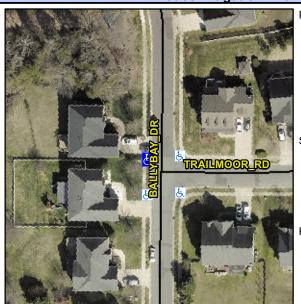
Field Measurements/Component Compliance								
Comp	liance Description	Data	Comp	liance	Description	Data		
N/A	Ramp Length (in)	49.0	Yes	Ram	Slope (%)	6.3		
No	Ramp Width (in)	47.0	No	No Ramp XSlope (%)		3.9		
N/A	Flare Type LT	N/A	N/A	N/A Flare Type RT		N/A		
N/A	Flare Slope LT (%)	N/A	N/A	N/A Flare Slope RT (%)				
N/A	Flare Traversable LT?	N/A	N/A	I/A Flare Traversable RT?				
N/A	Landing Length (in)	N/A	N/A	DWS Provided?		N/A		
N/A	Landing Width (in)	N/A	N/A	DWS	Contrast?	N/A		
N/A	Landing Slope (%)	N/A	N/A	DWS	Length (in)	N/A		
N/A	Landing X Slope (%)	N/A	N/A	DWS	Full Width?	N/A		
N/A	Landing Curb? (Y/N)	N/A	N/A	DWS	Offset (in)	N/A		
N/A	Shared Landing?	N/A						
N/A	Gutter Ponding?	N/A	N/A	Gutte	er Slope (%)	N/A		
N/A	Gutter Lip Ht (in)	N/A	N/A	Gutte	er X Slope (%)	N/A		
N/A	Painted X Walk1?	No	N/A	Paint	ed X Walk2?	N/A		
	X Walk 1 Direction	To SE		X Wa	lk 2 Direction	N/A		
N/A	X Walk 1 Width (in)	N/A	N/A	X Wa	lk 2 Width (in)	N/A

X Walk 1 Slope (%)	1.3		X Wa	lk 2 Slope (%)	N/A		
	X Walk 1 X Slope (%)	3.3		X Wa	lk 2 X Slope (%)	N/A		
N/A	Ramp inside XWalk1?	N/A	N/A	Ram	o inside XWalk2?	N/A		
	Road Slope (%)	N/A	N/A	Clear	Space?	N/A		
	Road X Slope (%)	N/A	N/A	Clear	Space to XWalk (in)	N/A		
N/A	Any Obstructions?	N/A	N/A	Storn	n Grate/Utility Hazard?	N/A		
	Obstruction Type			Storn	n Grate/Utility Type			
		N/A				N/A		
			Yes	Surfa	ce Condition? (G/P)	Good

i ossible colution	
Possible Solutions:	Co
Remove & Replace Entire Ramp.	N/A
	No
	N/A
	N/A
	N/A
	N/A
Surveyor Notes:	N/A
N/A	N/A
	N/A
	N/A
	N/A
PROW/ADA:	N/A
R304.5.1, R304.5.3	N/A
·	N/A
	N/A
	N/A
